Objective 4

Determine the optimum processing parameters & protocols for peeling coconut stems & the properties of the recovered veneer

Rob McGavin

Qld DAF

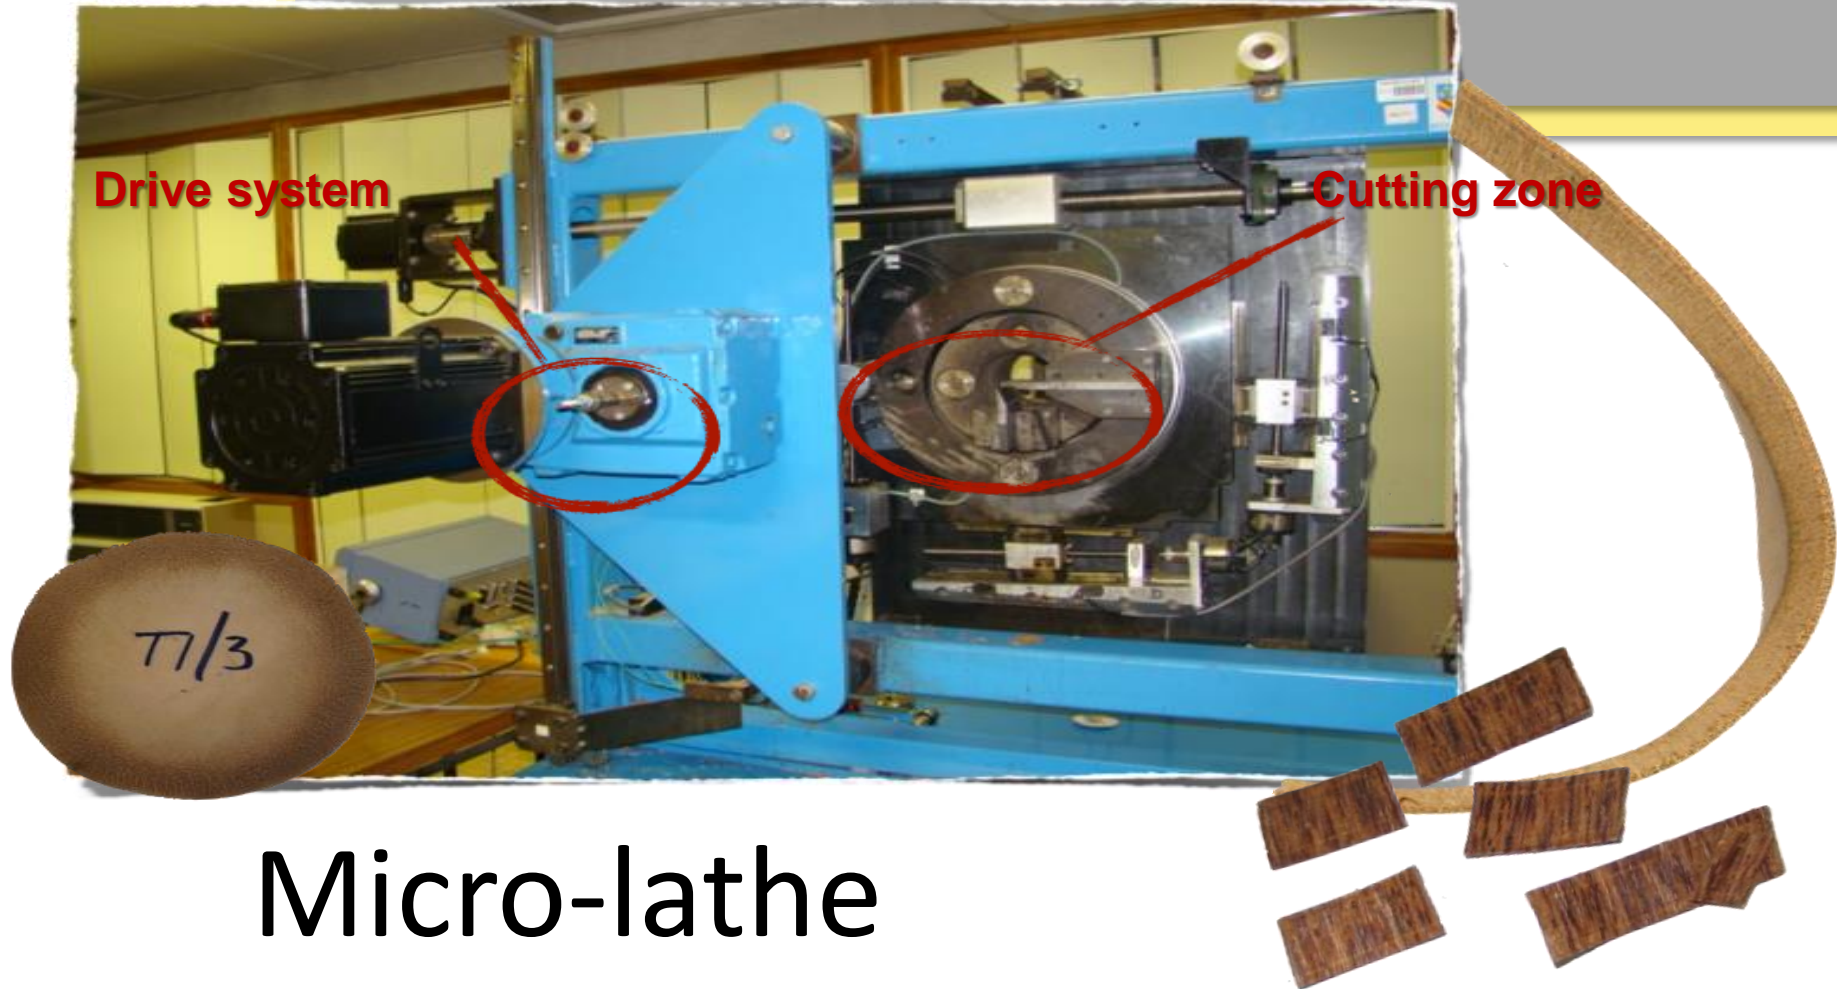
Micro-lathe

- **LAB SCALE** – determine optimum peeling parameters assessed from disc trials at ENSAM in France
- Micro-lathes used to determine lathe settings and stem pre-conditioning requirements

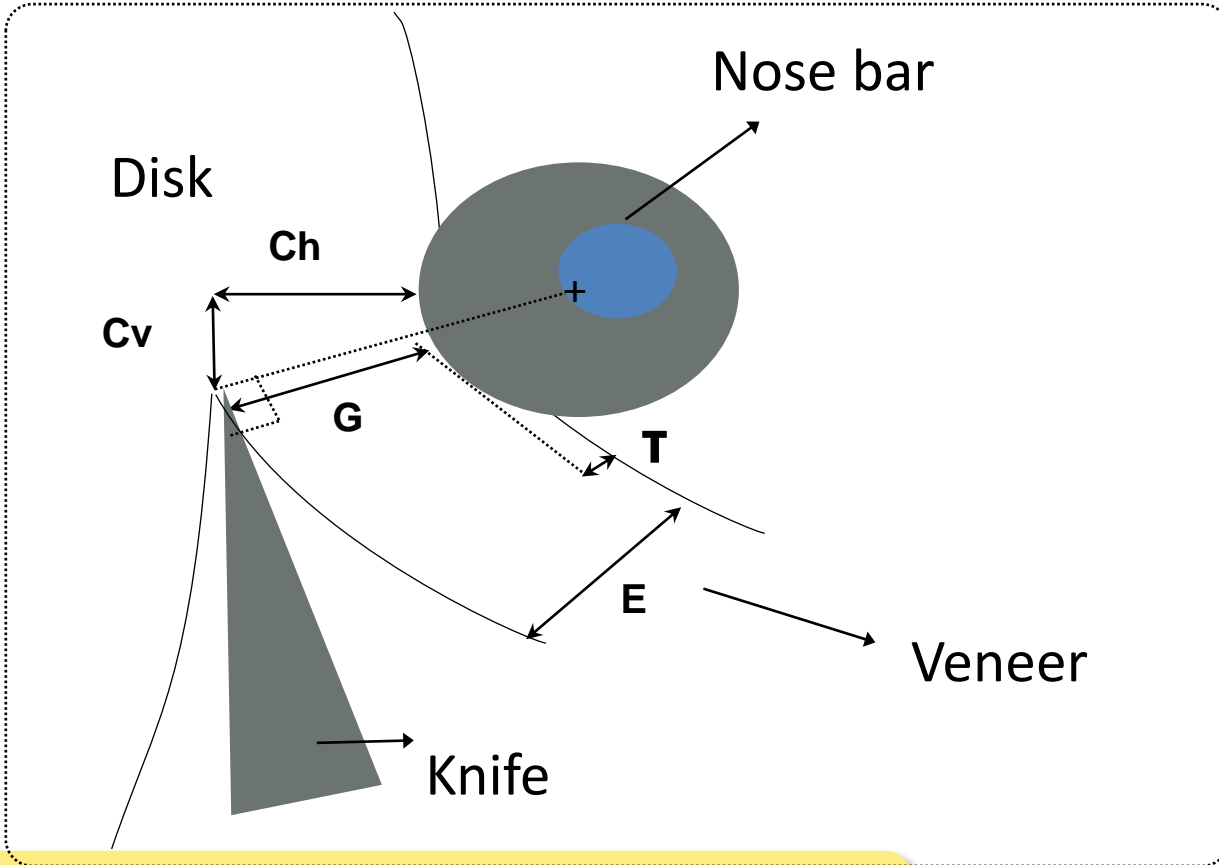
Trial 1 - Range of parameters trialed

G : Gap between knife and nose bar

E : Veneer Thickness

Ch : Horizontal Gap

Cv : Vertical Gap

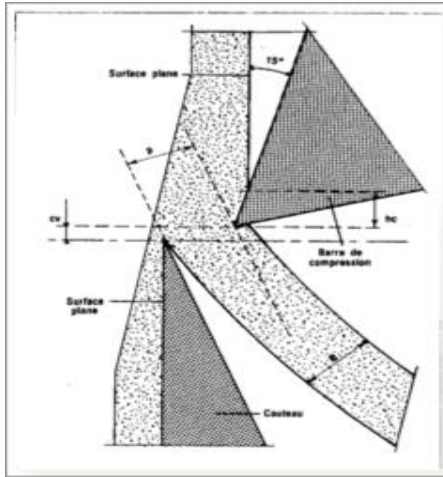
Trial 1 - Range of parameters trialed

Angular

Cylindrical

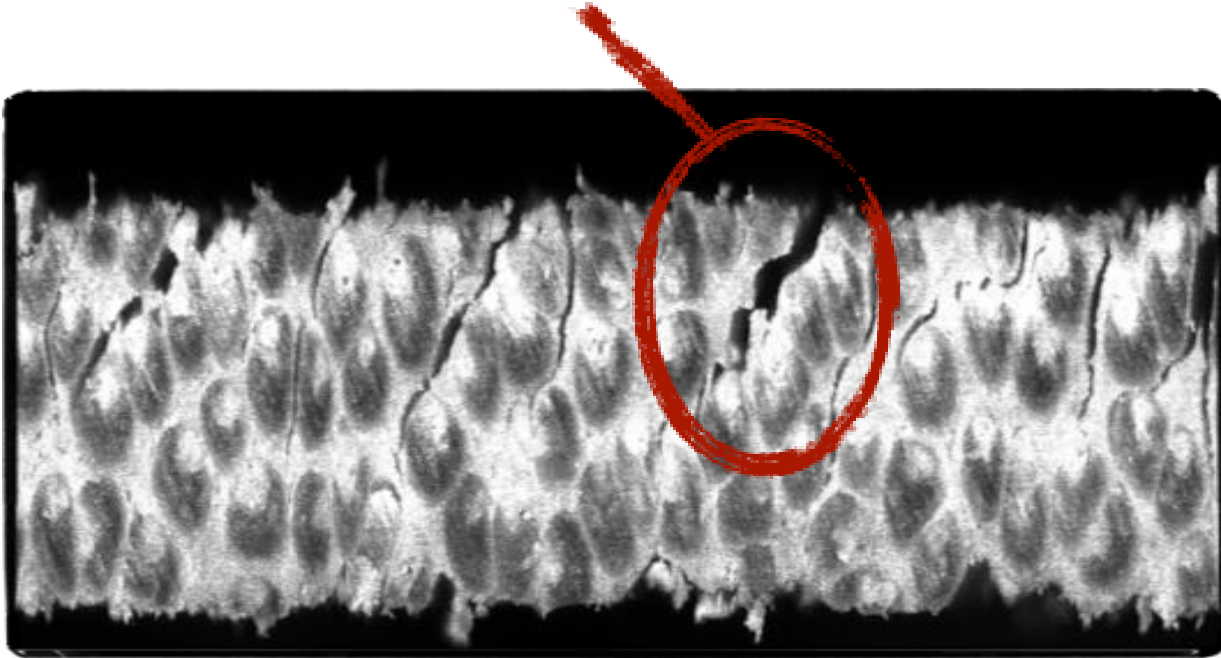
Trial 1 - Range of parameters trialed

Lathe checks

- Cutting Forces**
The forces exerted in the cutting plane, both on the pressure bar and the knife, were measured using piezoelectric load cells.
- Veneer Quality**
A specifically designed apparatus (SMOF) (2), optical system) was used to characterize veneer lathe checks. Veneer checks produced during peeling are opened by bending the veneer on a diameter roller. The software algorithm identifies each check, calculates its depth, and determines the distance between consecutive checks. Only veneers with a visual score of 2 or above were assessed with the SMOF.

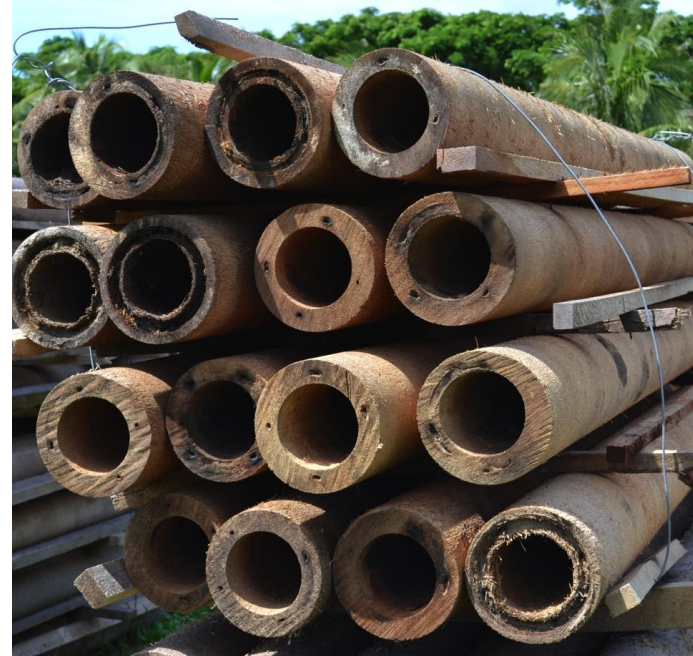
- Peeling trials in order to validate and refine parameters established during Trial 1
- Difficulties sourcing suitable coconut billets
 - North Qld billets – low/medium density
 - Fiji high density hollow billets – not successful
- Modified lathe preliminary testing

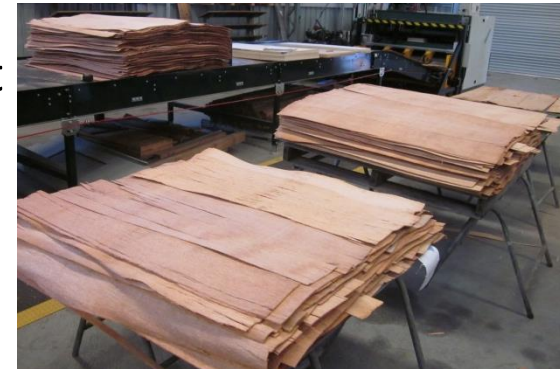
- Lathe performed well
- Some issues with supporting equipment
 - pretreatment chamber: couldn't heat logs hot enough!
- 23 logs (1.5 m³), 249 veneer sheets
- Around 60% recovery
- Veneer quality negatively impacted by lack of log heating capacity and lack of opportunity to optimise lathe settings
- Quality and volume insufficient for product development
- Additional processing scheduled in June 2015
 - Supporting equipment not prepared
 - Logs weren't available

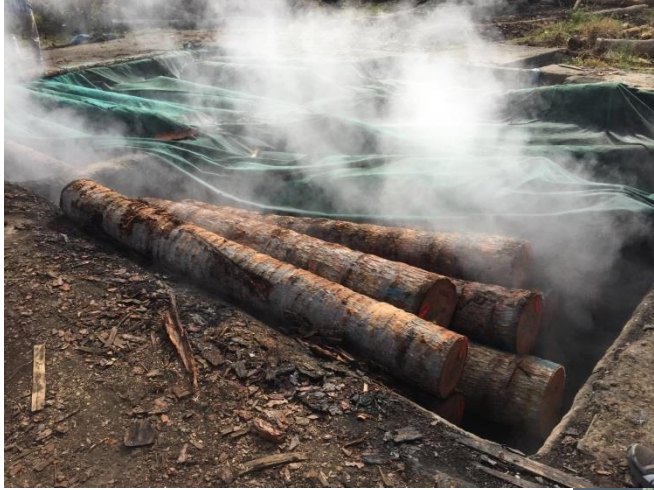
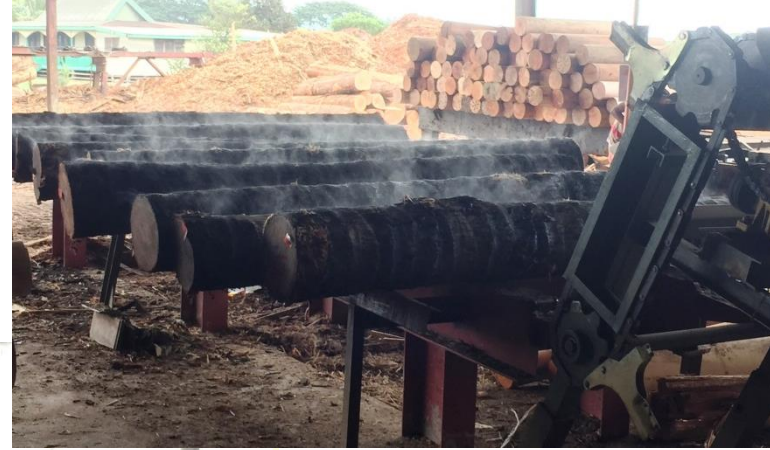
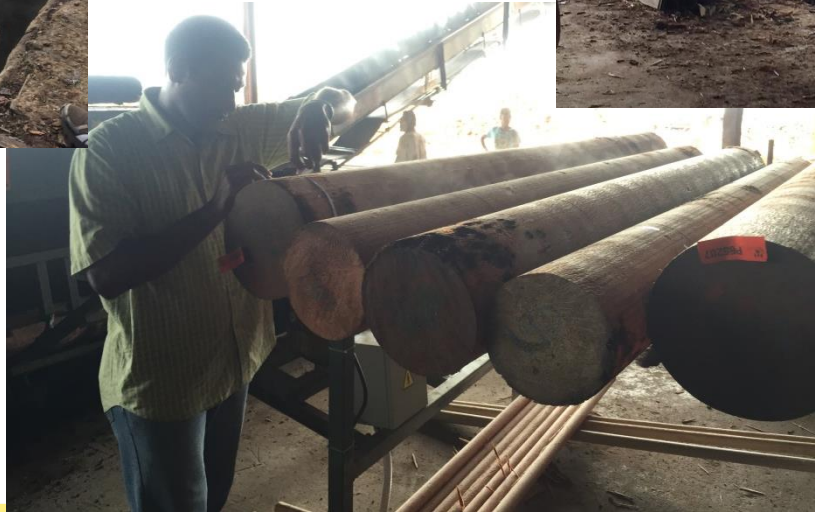
Trial 4 – VTB commercial trial

- Completed in June 2015
- 171, 2500mm billets processed
- About 15 m³ of veneer
- Demonstrated the challenges of peeling coconut
- Further reinforced the necessity of billet pre-conditioning
- No drying challenges
- Good quantity of suitable quality veneer for product development activities.

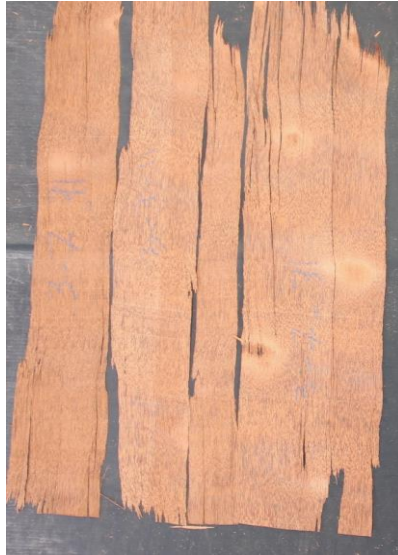
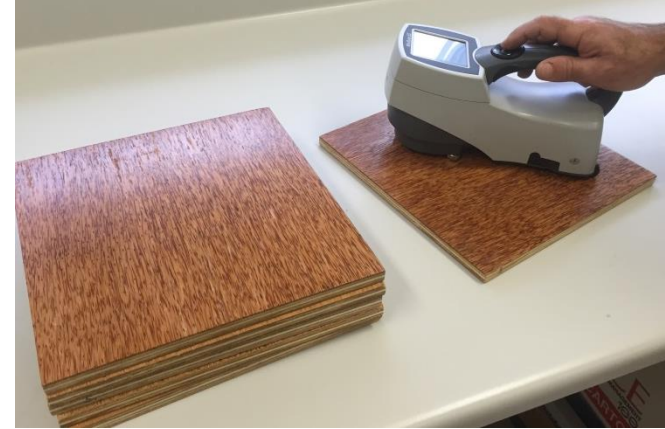
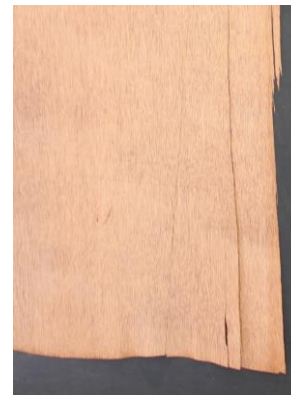
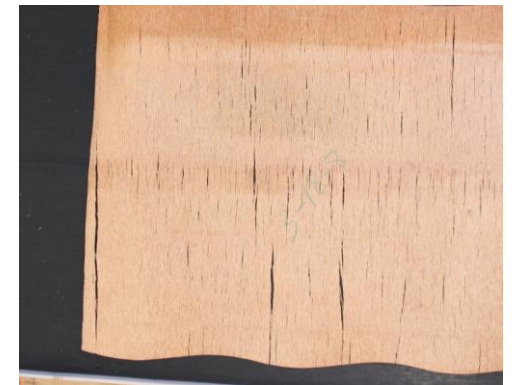
Visual assessments

- Colour
- **Roughness**
- **Splits**
- Brittleness
- **Collapse**
- Decay
- Compression
- Wane
- Insects, etc

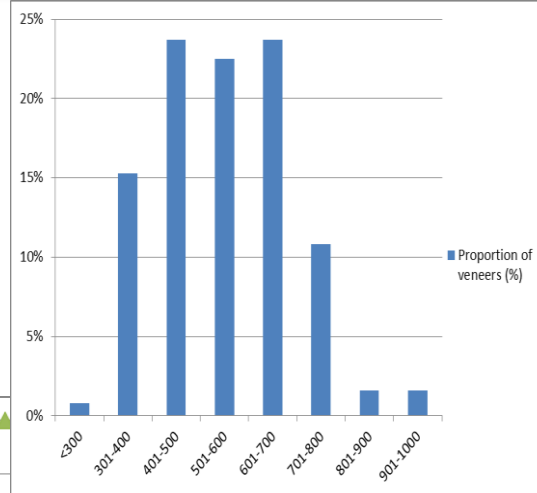
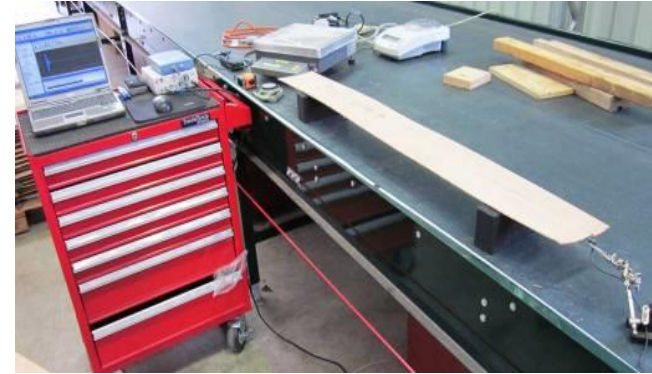
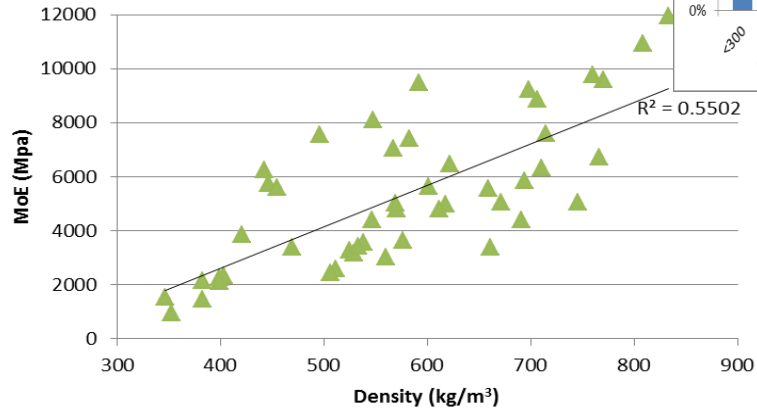
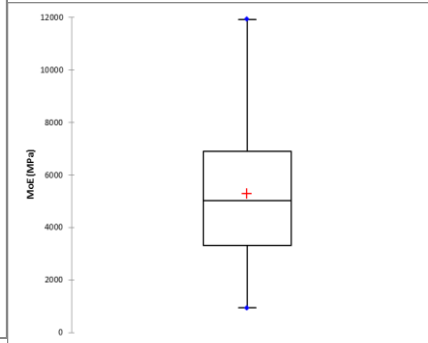
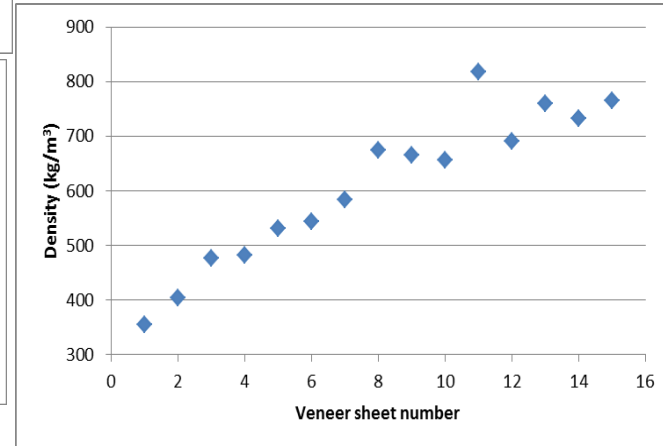
Properties assessments

- Density
- Stiffness (MoE)

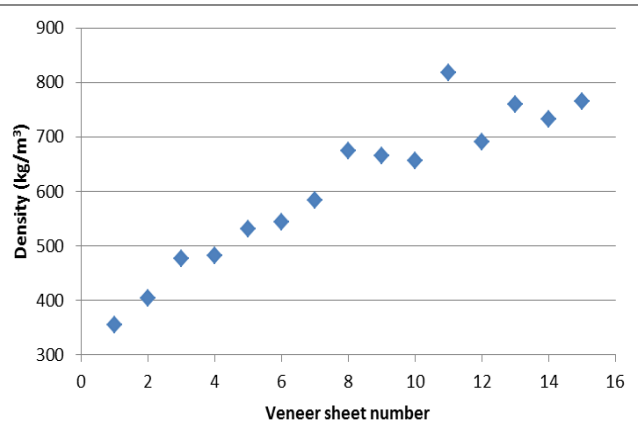
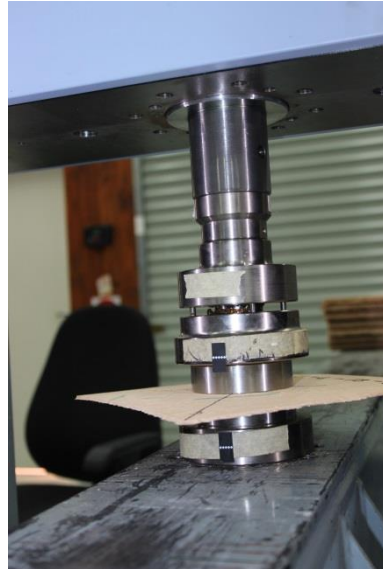
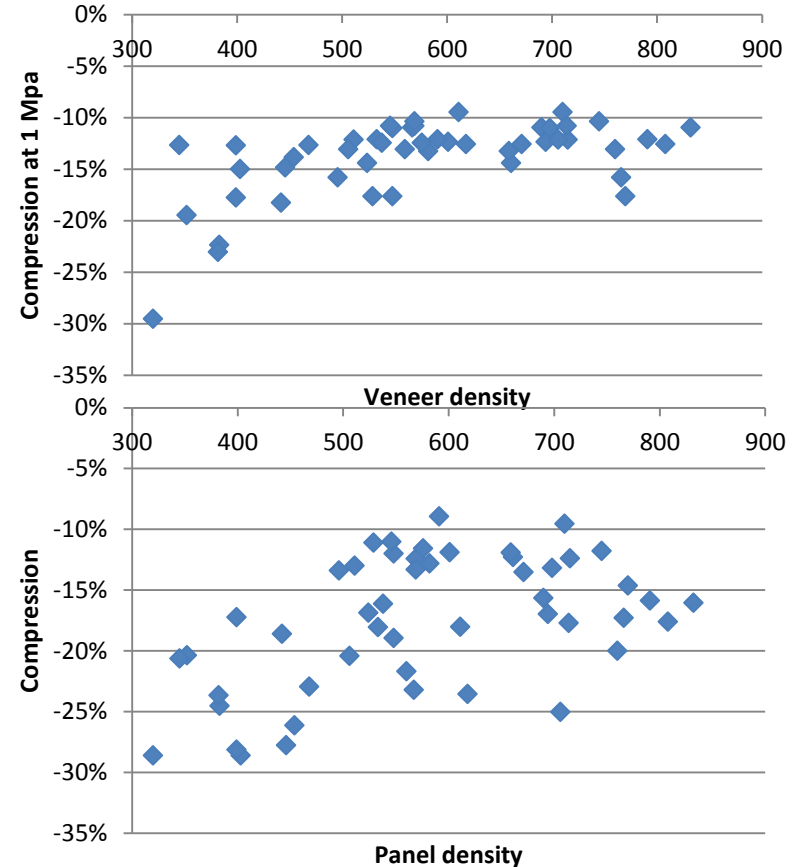
Pressing characteristics

- Material behavior
- Influence of temperature and adhesive
