Peeling coconut stems for high quality rotary veneer

Dr Rob McGavin

Queensland Department of Agriculture & Fisheries

June 2016

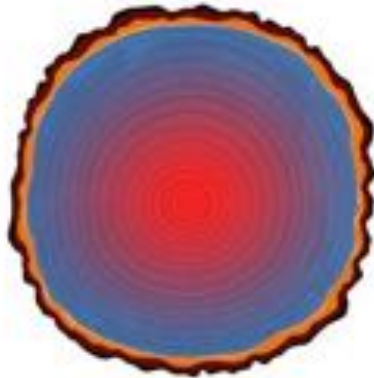
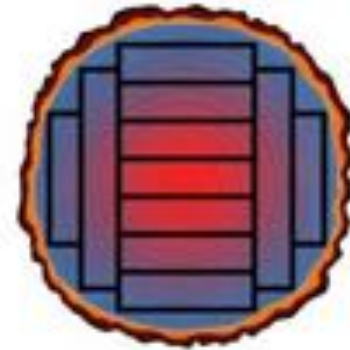
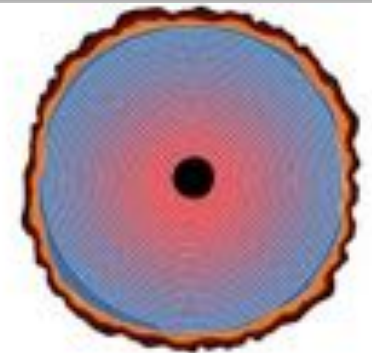
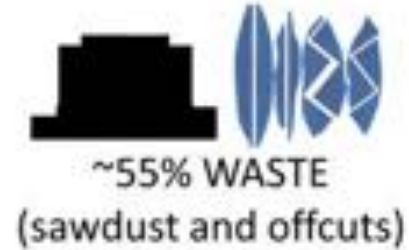
Sawing v's Peeling

~45% PRODUCT

~75% PRODUCT

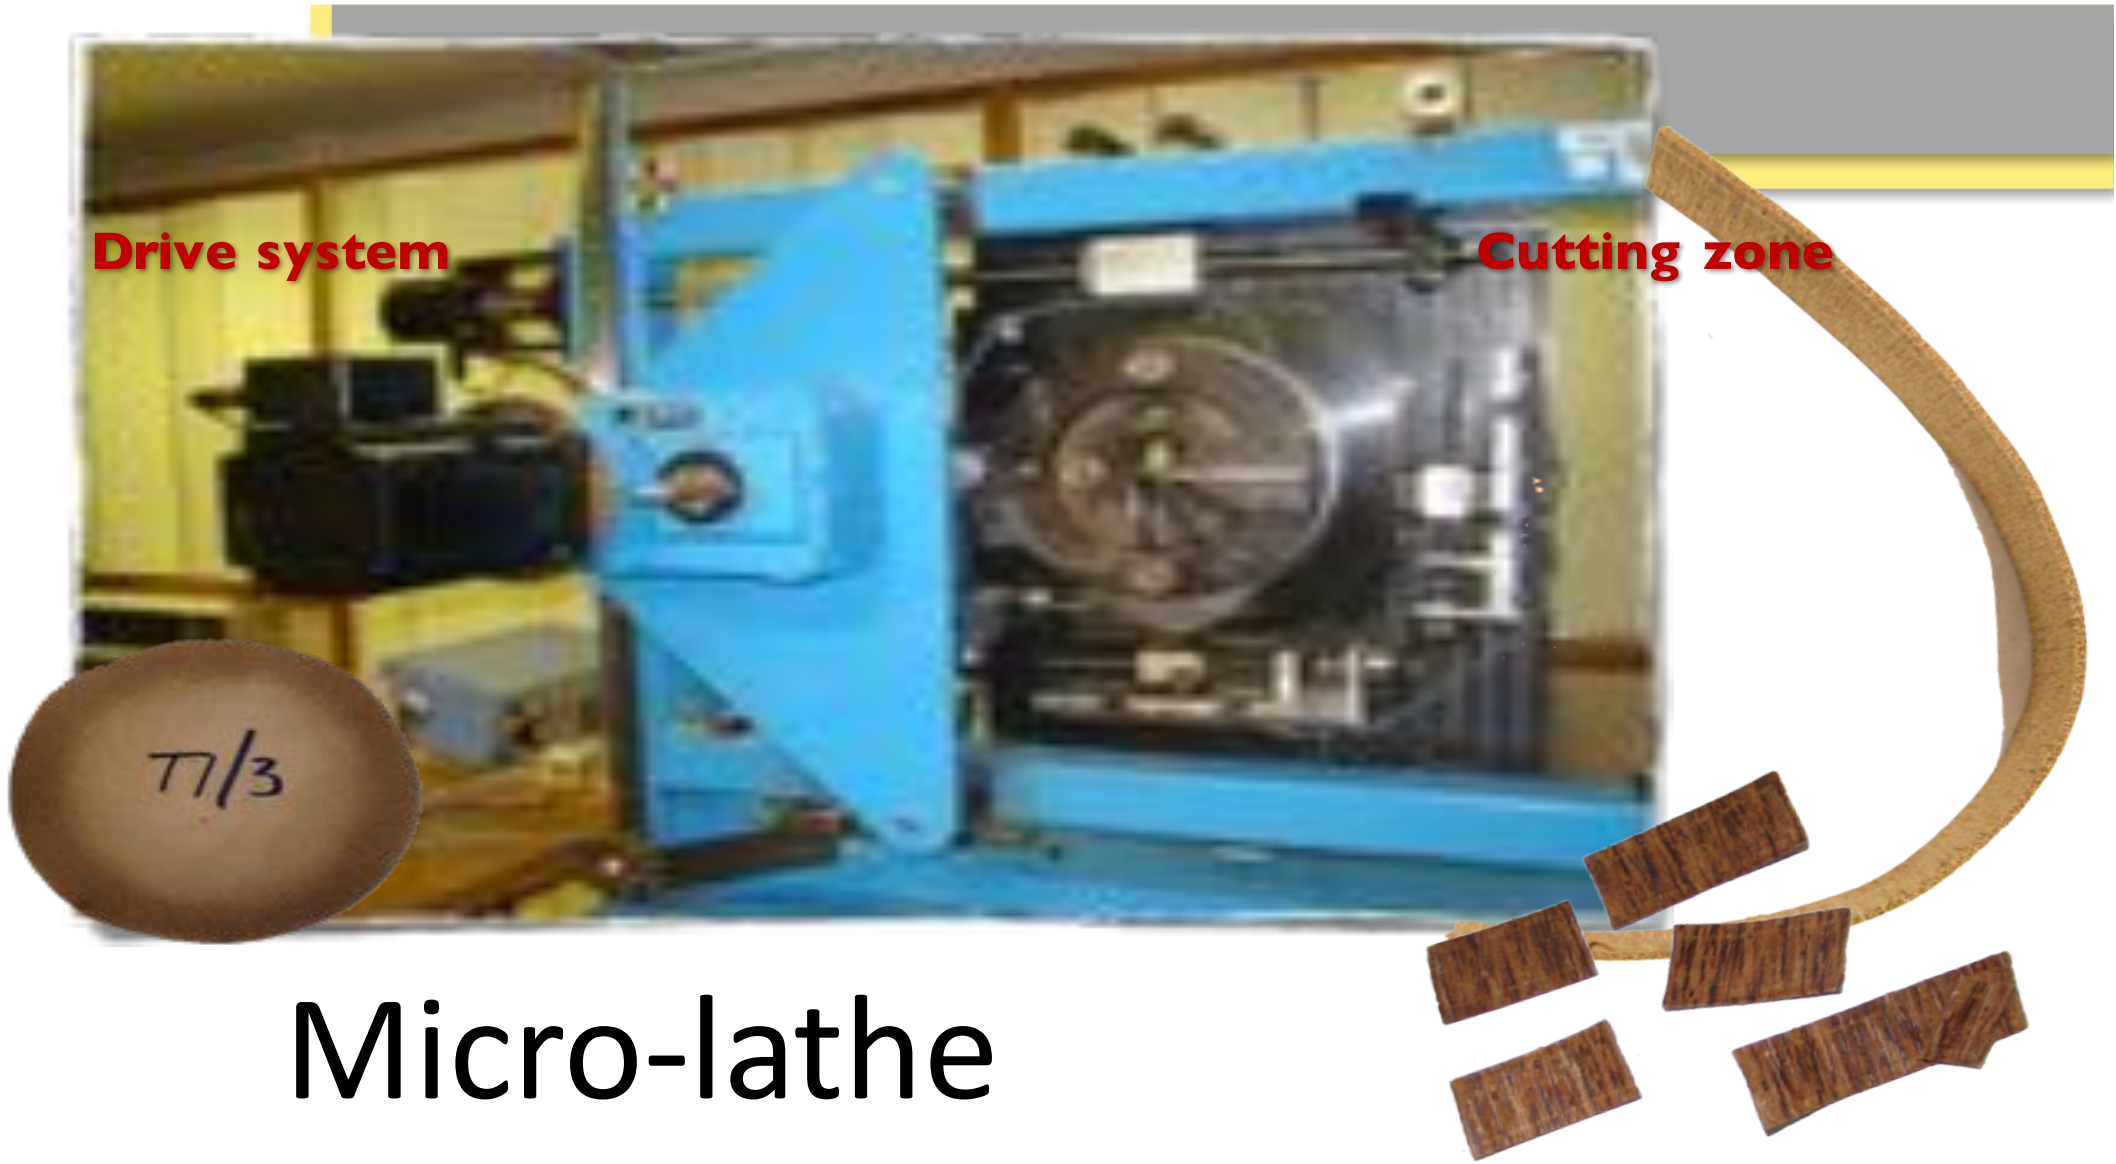
Micro-lathe

Stage 1 - Range of parameters trialed

Lathe checks

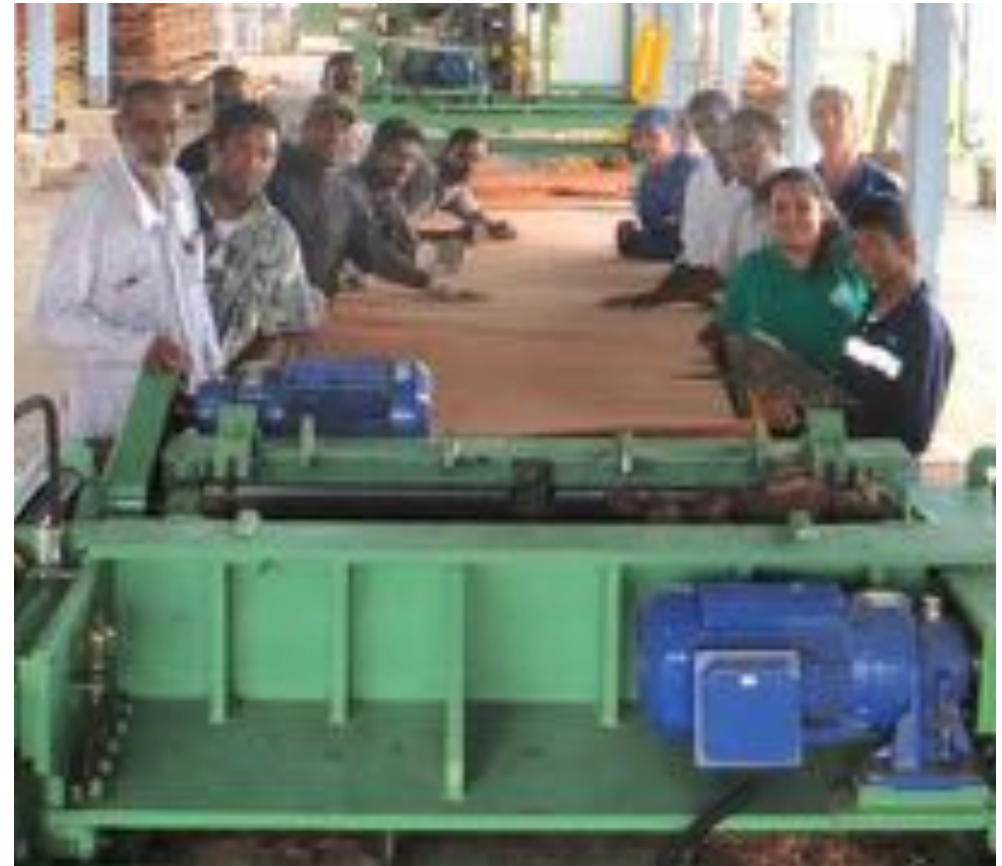
Stage 3 – TUD

- Lathe performed well
- Some issues with supporting equipment
- Veneer quality negatively impacted by lack of log heating capacity
- 23 logs, 249 veneer sheets

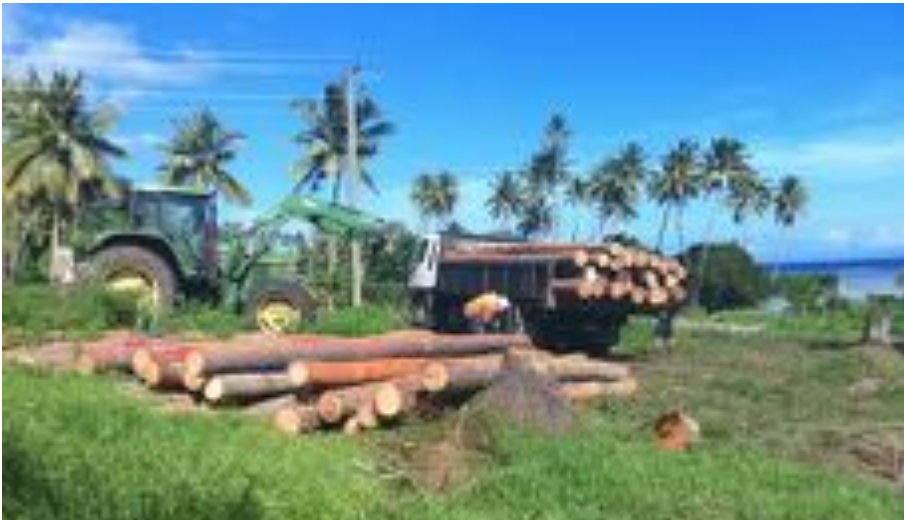
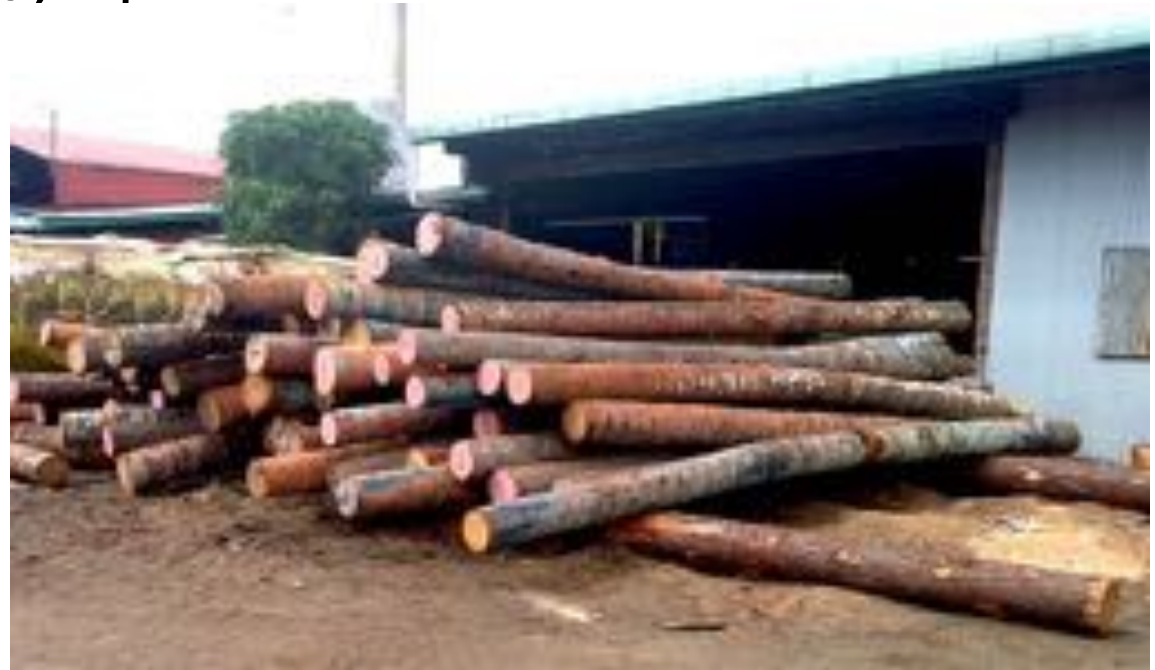
Stage 4 – VTB commercial trial

- Scale up to industrial production environment
- VTB commercial mill at Labasa, Fiji
- Lathe settings verified

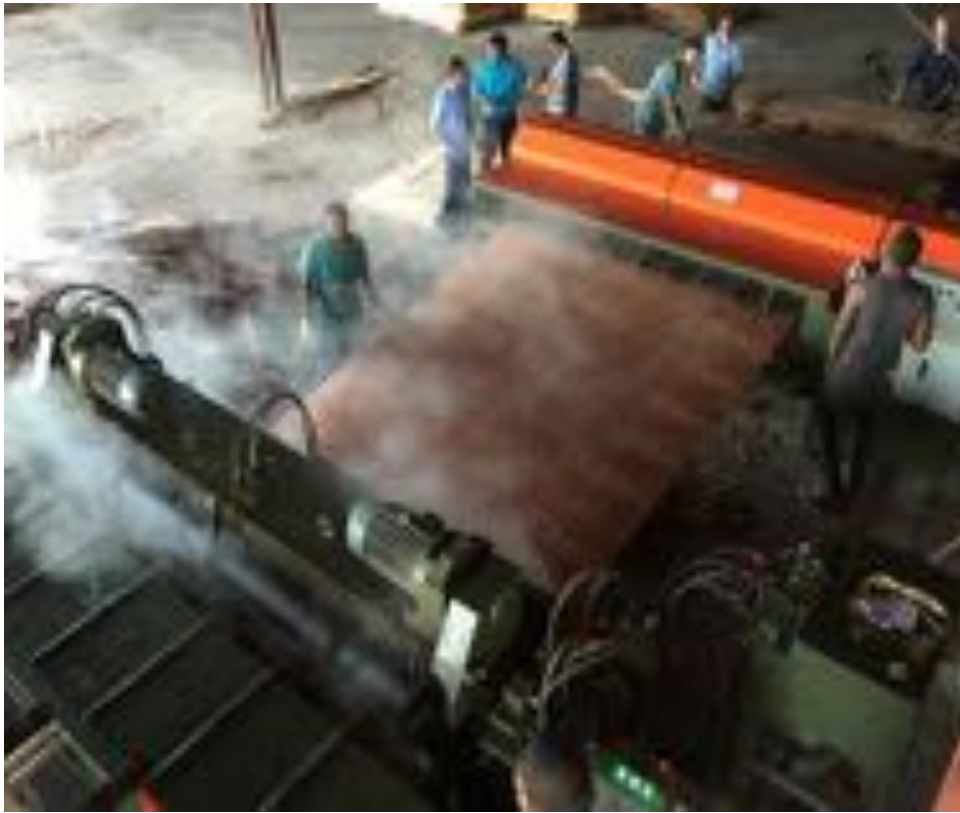
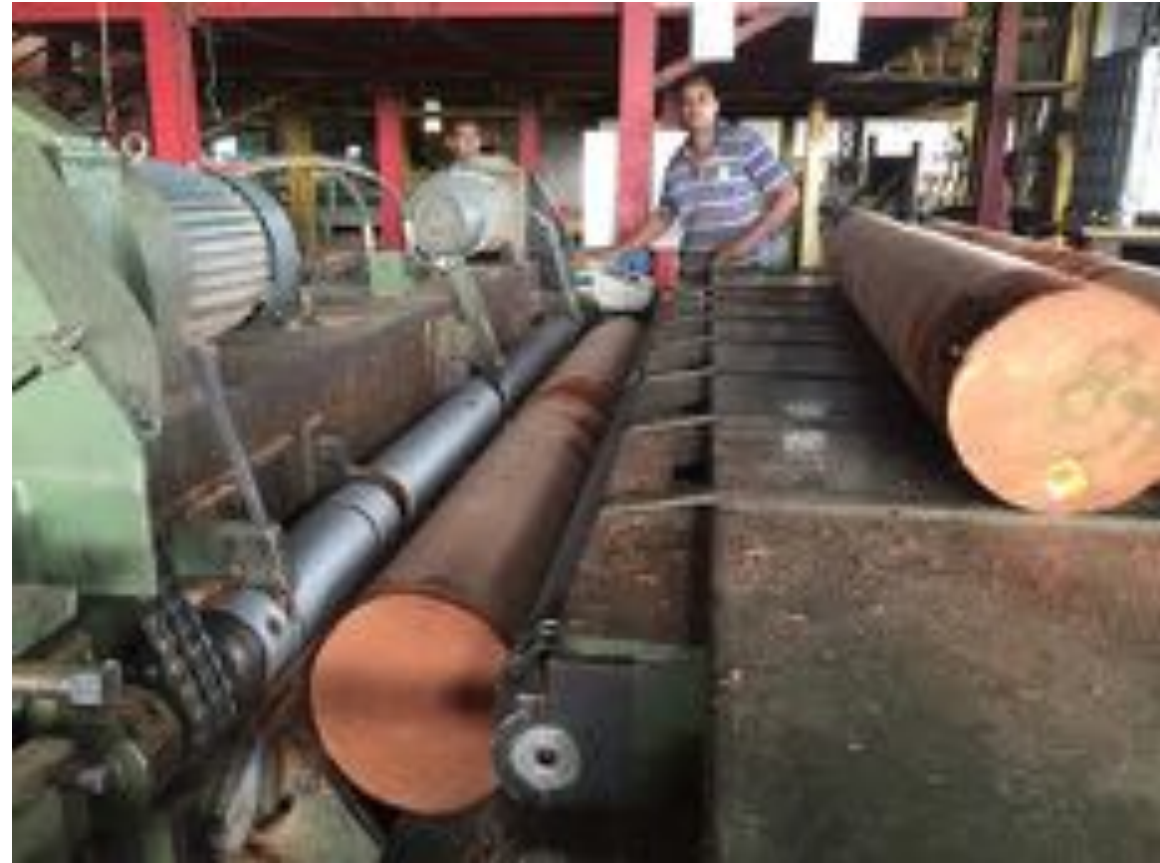
Stage 4 – VTB commercial trial

Confirmed unique lathe settings

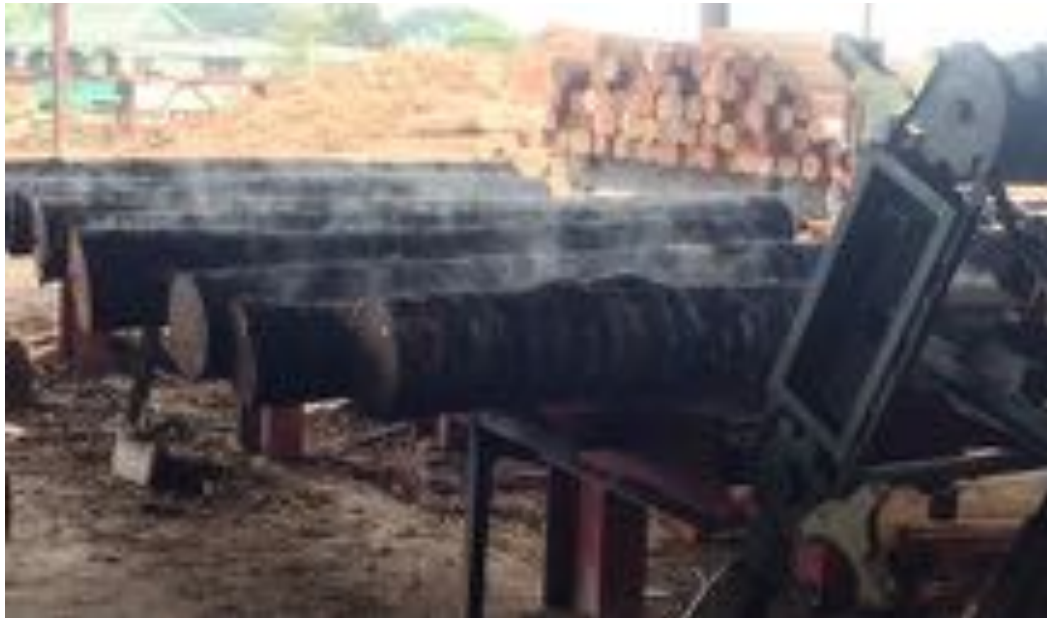
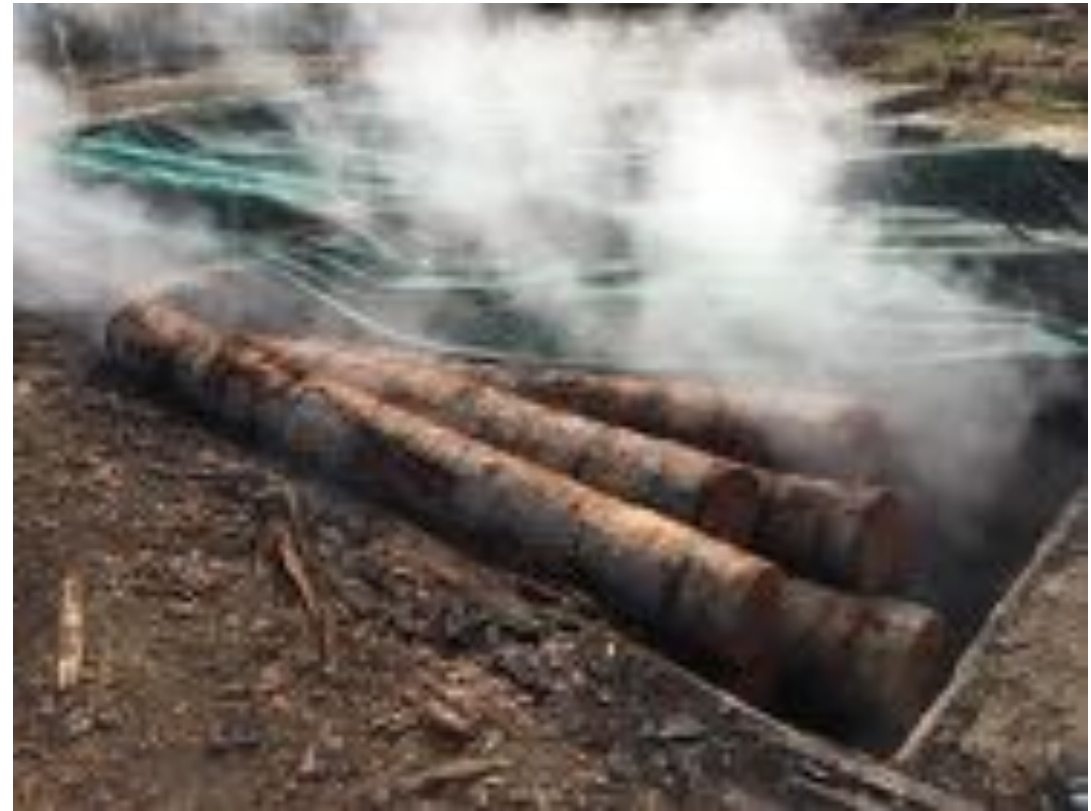
Stage 4 – VTB commercial trial

Log heating critical

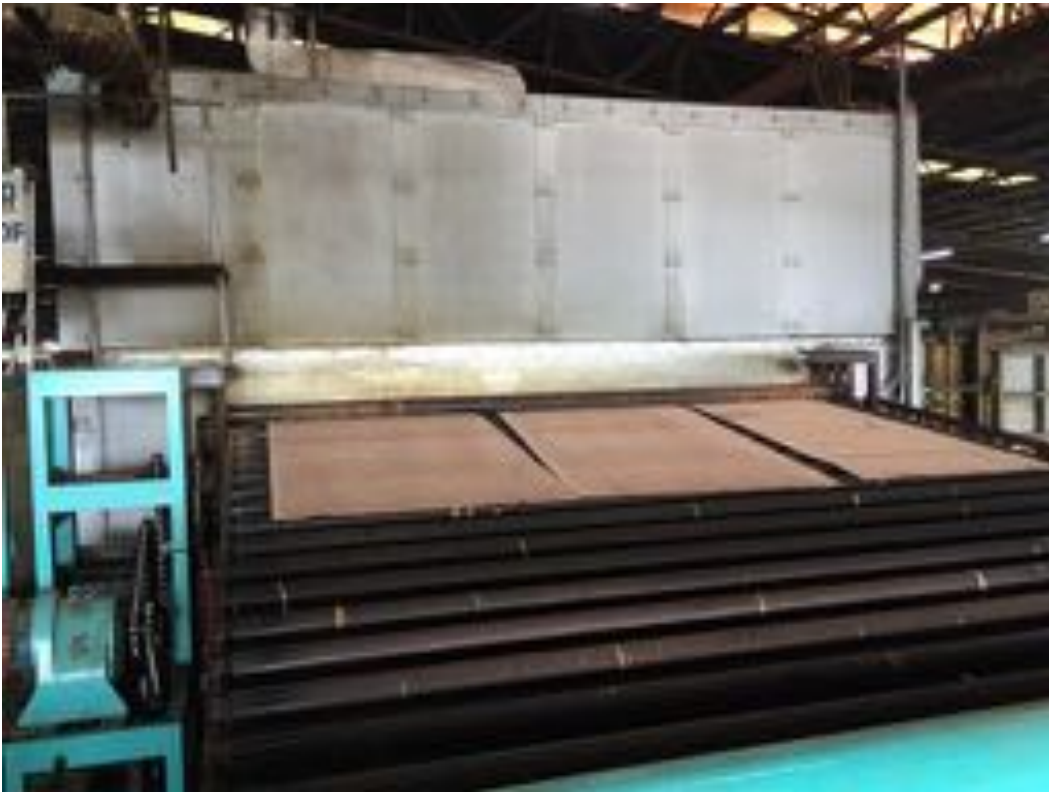
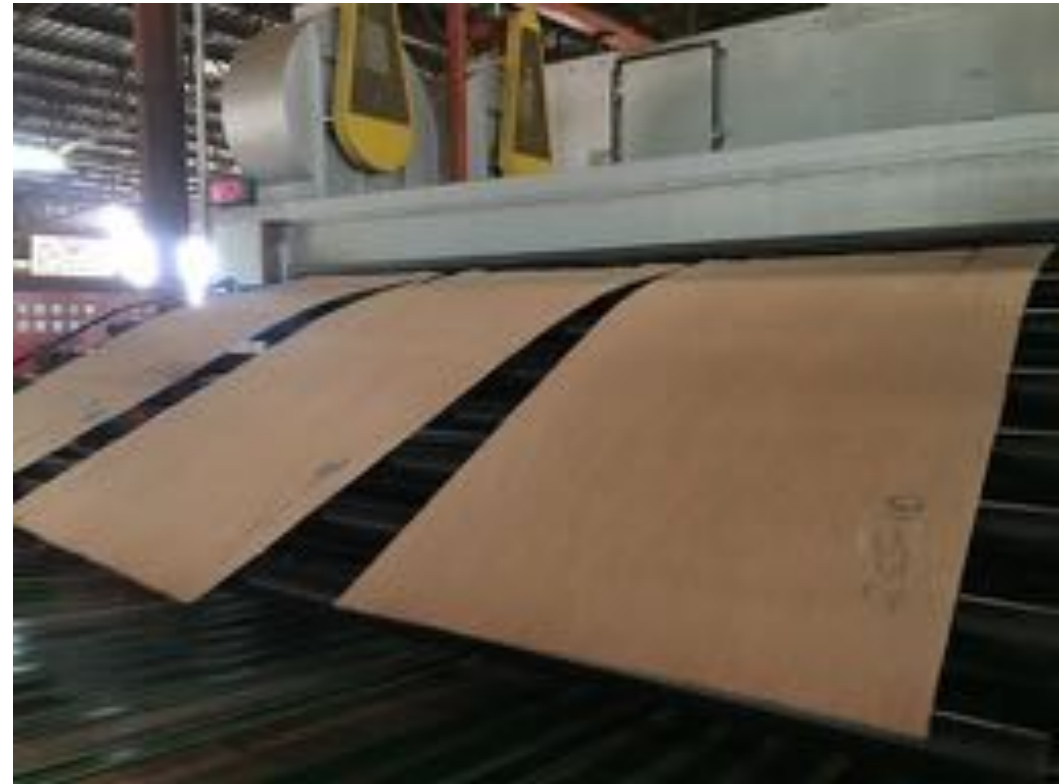
Stage 4 – VTB commercial trial

Quick and easy drying

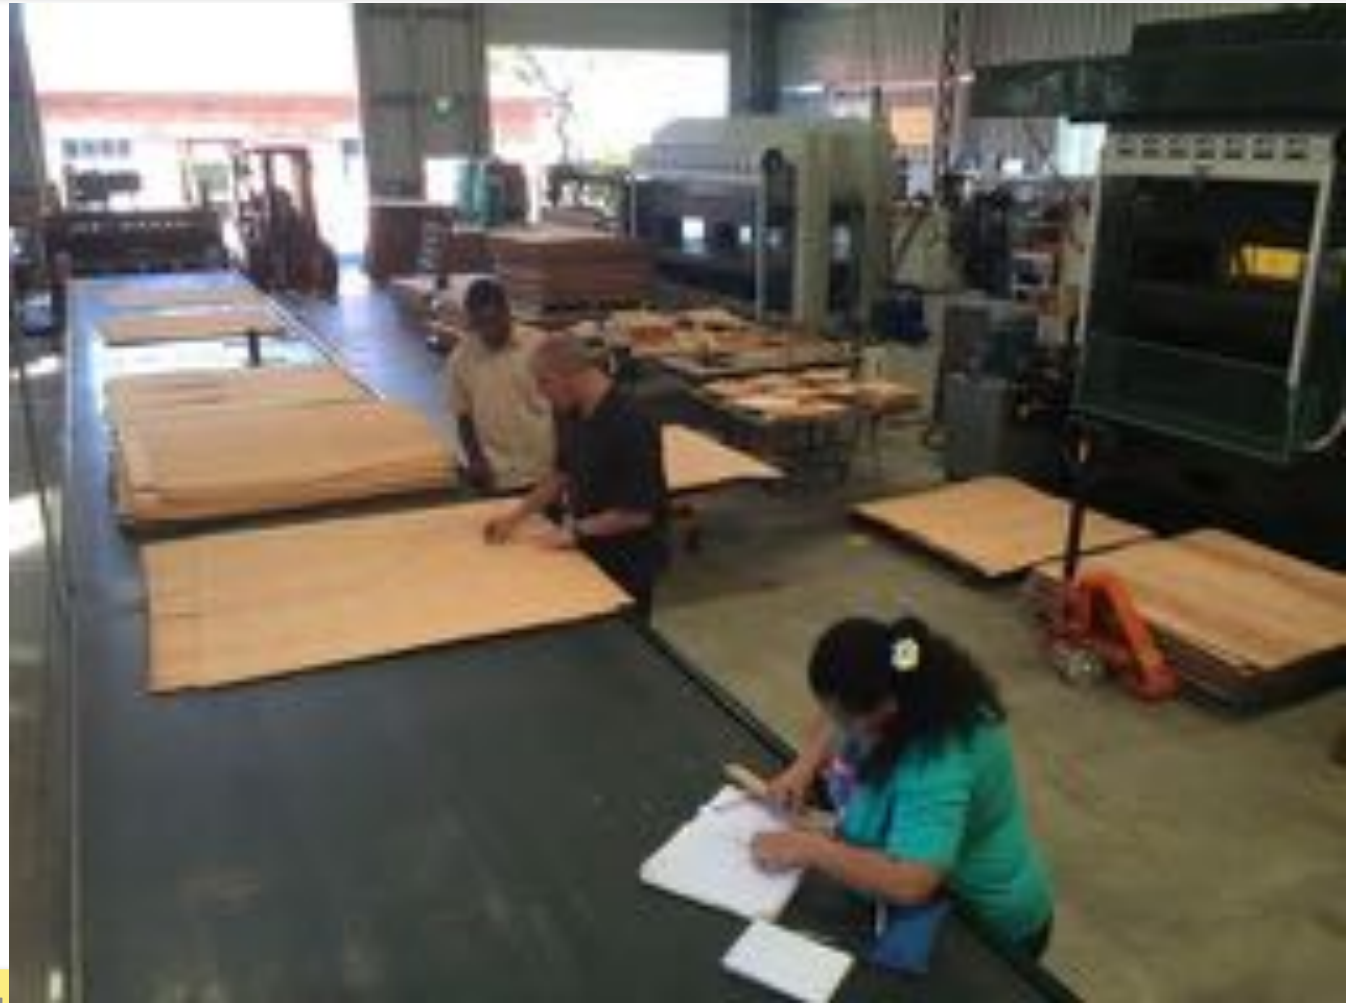
Veneer assessment

Visual assessments

- Colour
- **Roughness**
- **Splits**
- Brittleness
- **Collapse**
- Decay
- Compression
- Wane
- Insects, etc

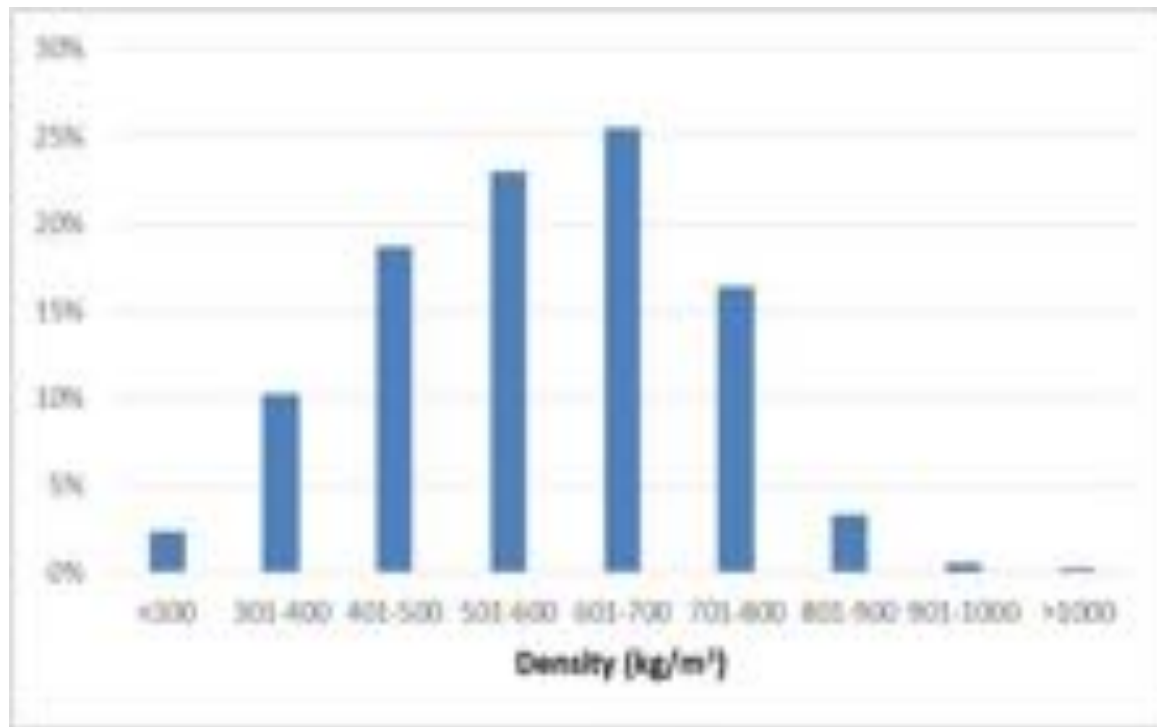
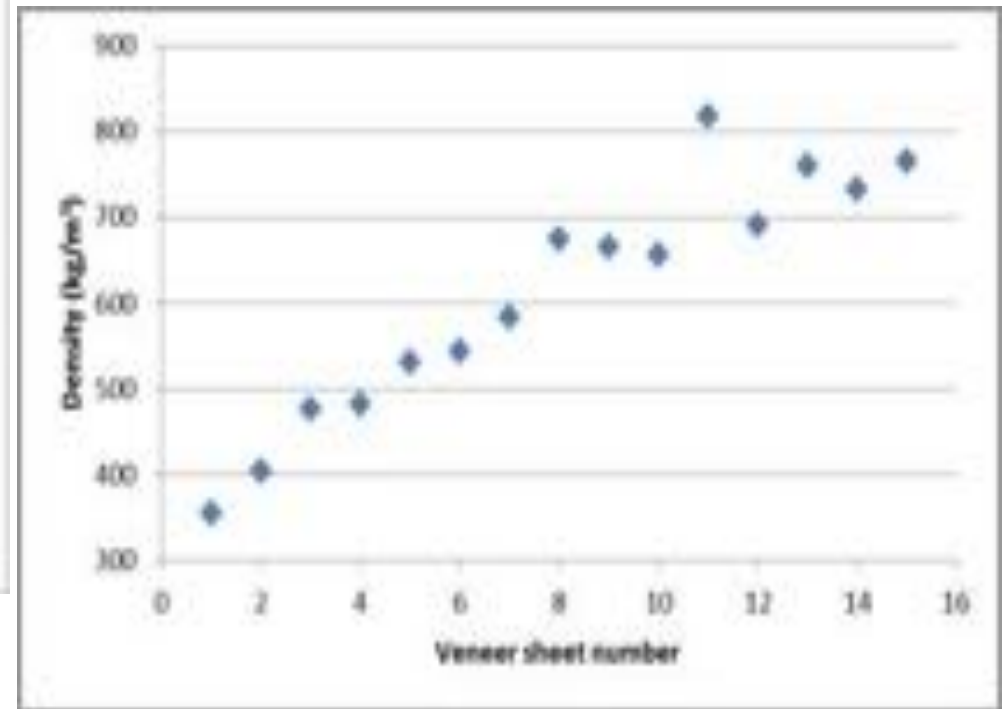
Veneer assessment

Density

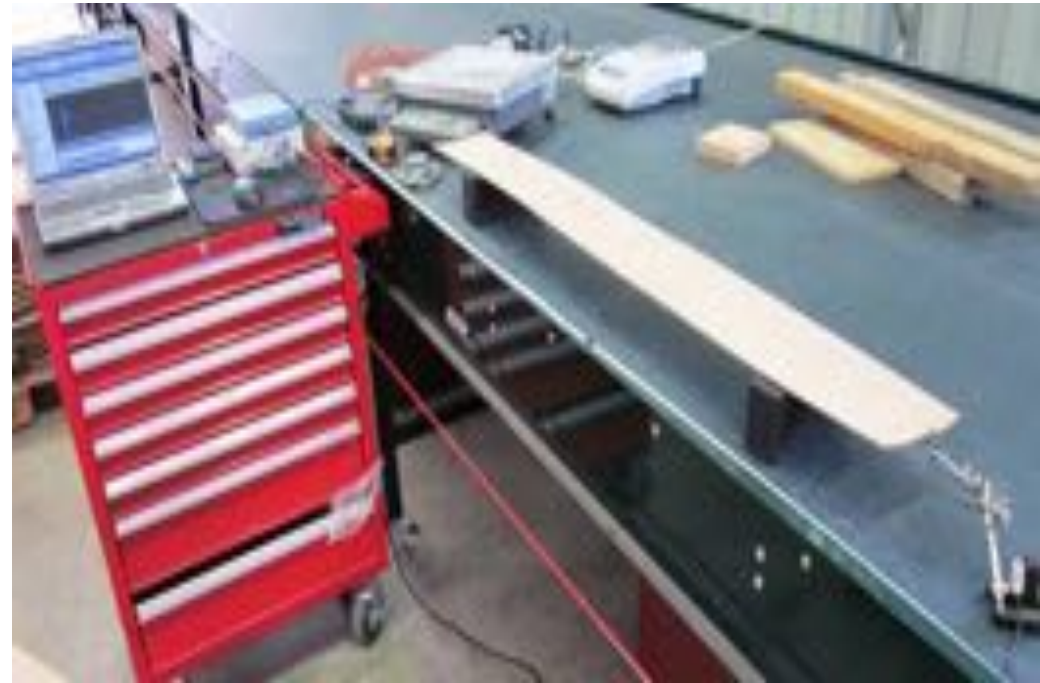
Veneer assessment

Stiffness (Modulus of Elasticity)
