ACIAR FST/2009/062 Development of advanced veneer and other products from coconut wood to enhance livelihoods in South Pacific communities

DAF Report - Coconut palm stem veneer processing

Trial 3

July 2015

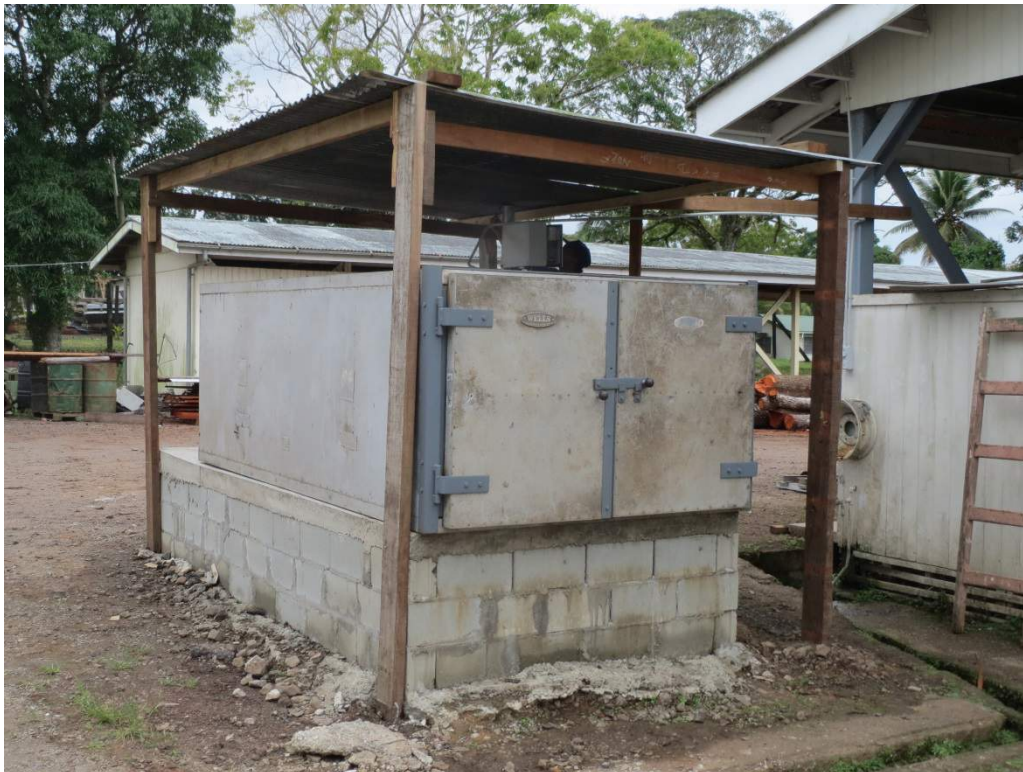
Logs were docked to approximately 1300 mm lengths prior to pre-conditioning. The benefits of pre-conditioning coconut palm stems prior to rotary peeling were demonstrated in Processing Trial 1 and reported by Bailleres *et al.* (2015). The pre-conditioning process involves heating the billets without moisture loss, to soften the log making the peeling operation easier and improving the resulting veneer quality. Temperatures above 80 degrees Celsius are necessary to gain the most benefit from reducing lathe cutting forces and improving veneer quality. A log temperature of 85 degrees Celsius was targeted for the trial. Pre-conditioning was undertaken in an enclosed chamber with heating provided via saturated steam (Image 1). Logs were pre-conditioned for approximately 14-18 hours prior to peeling.

Image 1 – Chamber used to pre-condition coconut palm stem logs prior to peeling

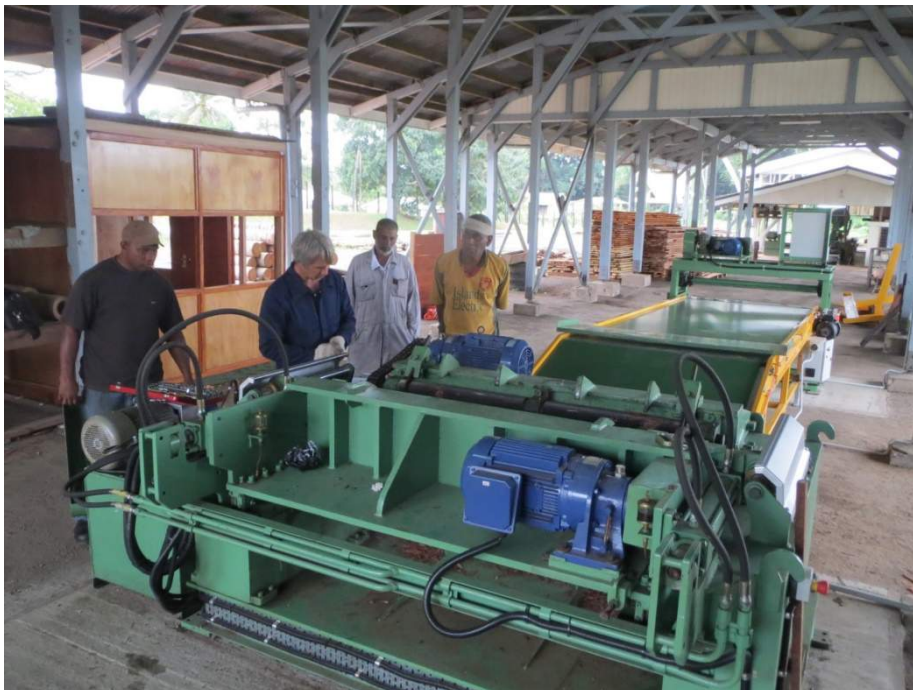
Rotary peeling was performed using a Malaysian-built spindleless veneer lathe (Image 2). While the lathe manufacturer had some experience with rotary peeling coconut stems, and the lathe included some design features specifically for peeling coconut stems, the knowledge and experience of the manufacturer had been restricted to low to medium density coconut only (e.g. $<600 \text{ kg/m}^3$). Spindleless lathe performance and optimal settings for higher density coconut (i.e. $>600 \text{ kg/m}^3$) are largely unknown. For this reason, the trial intended to include a range of lathe settings to progressively fine tune the peeling performance as the trial proceeded. Information from the lathe manufacturer, DAF experience in spindleless lathe operation combined with the laboratory peeling trials reported by Bailleres *et al.* (2015) provided the base line initial settings and guided subsequent changes. The minimum residual or peeler core size was 60 mm.

Image 2 –Spindleless veneer lathe used for peeling coconut stems

The veneer lathe performed satisfactorily and successfully peeled coconut stems with densities up to around 800 kg/m³. Design and commissioning problems with some supporting equipment items limited the scope and success of the trial. In particular, the pre-conditioning chamber prevented optimal log temperatures from being reached. This certainly negatively impacted the quality of the veneer produced during the trial and also prevented substantial gains in developing more optimal lathe settings and processing protocols.

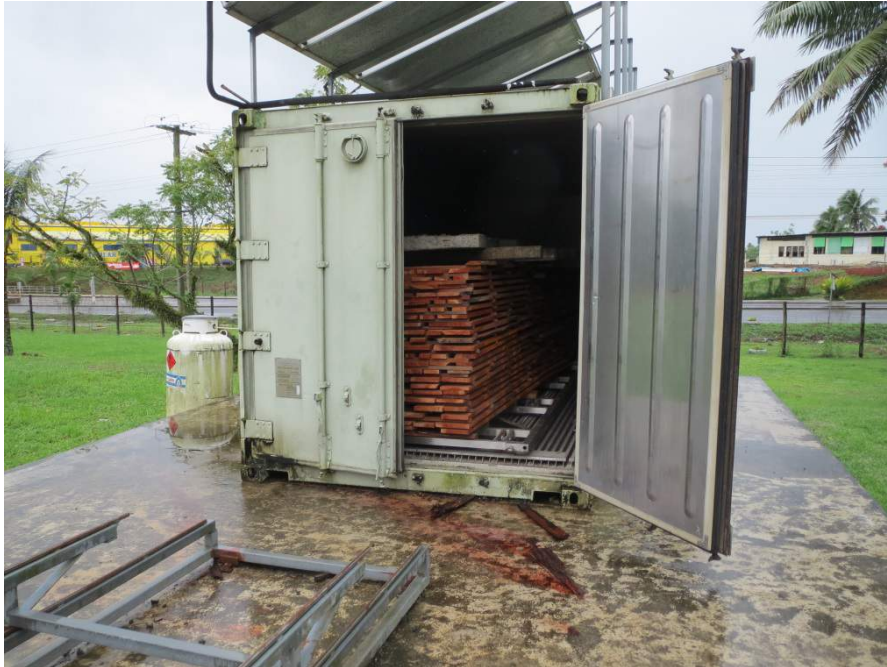
Veneer stacks were loaded into a gas-assisted solar kiln (Images 3 and 4) and dried to a target moisture content (MC) of approximately 10%. Dried veneers were re-stacked, packaged and forwarded to the DAF Salisbury Research Facility in Brisbane, Australia.

Image 3 – Gas-assisted solar kiln designed for solid timber drying.

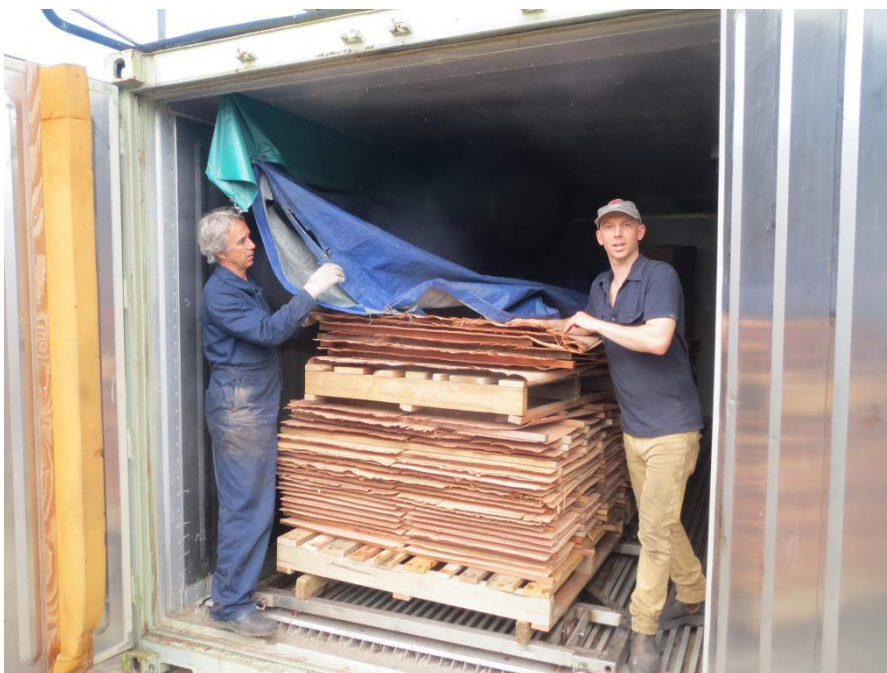
Image 4 – Cocoveneer was dried using conventional solid wood drying protocols.

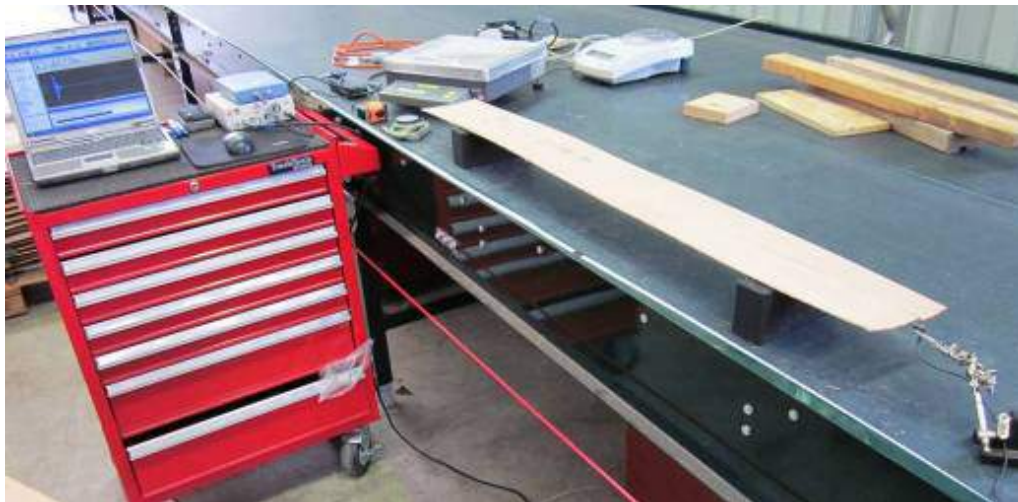
sheet, a sampling strip was removed which measured 150 mm (parallel to the grain) by approximately 1,200 mm long. The sampling strips were conditioned to 12% MC prior to measurement. Veneer MoE measurements followed using an acoustic natural-vibration method as described by Brancheriau and Bailleres (2002) (Image 5). Sample strip dimensions (length, width and thickness) and weight were measured allowing veneer density to be calculated for the specific sample on which MoE was measured.

Image 5 – Modulus of elasticity measurement on cocovenier sampling strips.

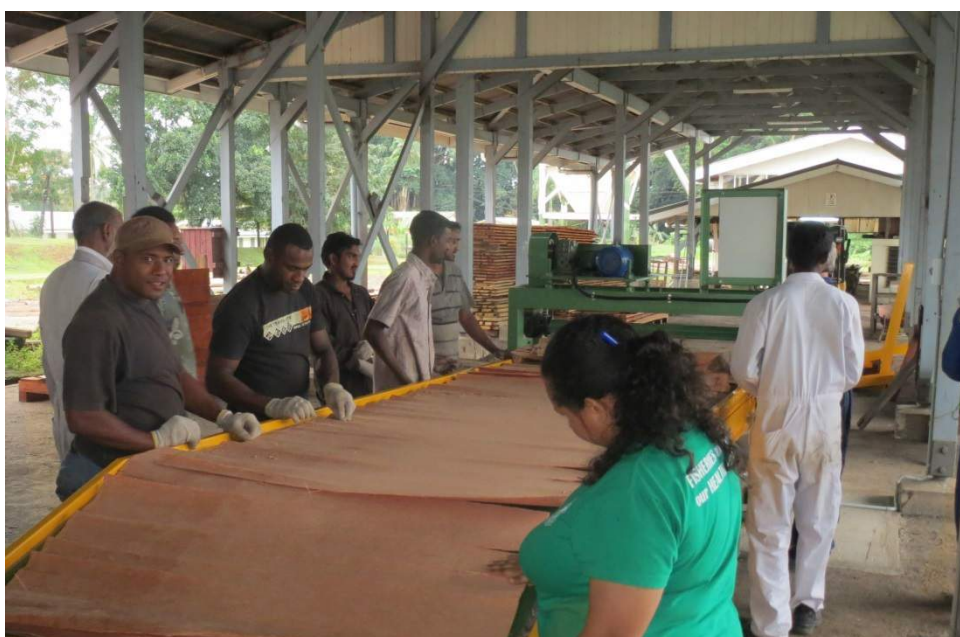
Twenty-three coconut logs totally approximately 1.47 m³ were processed during the trial (Image 6). A total of 249 veneer sheets were produced resulting in 0.89 m³ of dried veneer. A gross veneer recovery of approximately 61% was achieved. While this recovery rate is very close to the gross recovery rates reported by McGavin *et al.* (2014) for veneer processing young, plantation-grown hardwood logs, there were some differences in methodologies between the two studies. For example, the method of calculating log volumes differed slightly. For the results reported by McGavin *et al.* (2014), log volumes were calculated on de-barked but unrounded logs, whereas this trial used the log diameter measured after cortex removal and log rounding. This would lead to a slightly inflated recovery rate by comparison. Also, a larger peeler core size was set for the cocoveneer trial (i.e. 60 mm versus 45 mm) meaning the log volume available for veneer production was less. The sub-optimum log peeling temperature would also have negatively affected the potential recovery rate.

Image 6 – Cocoveneer produced on a spindleless veneer lathe

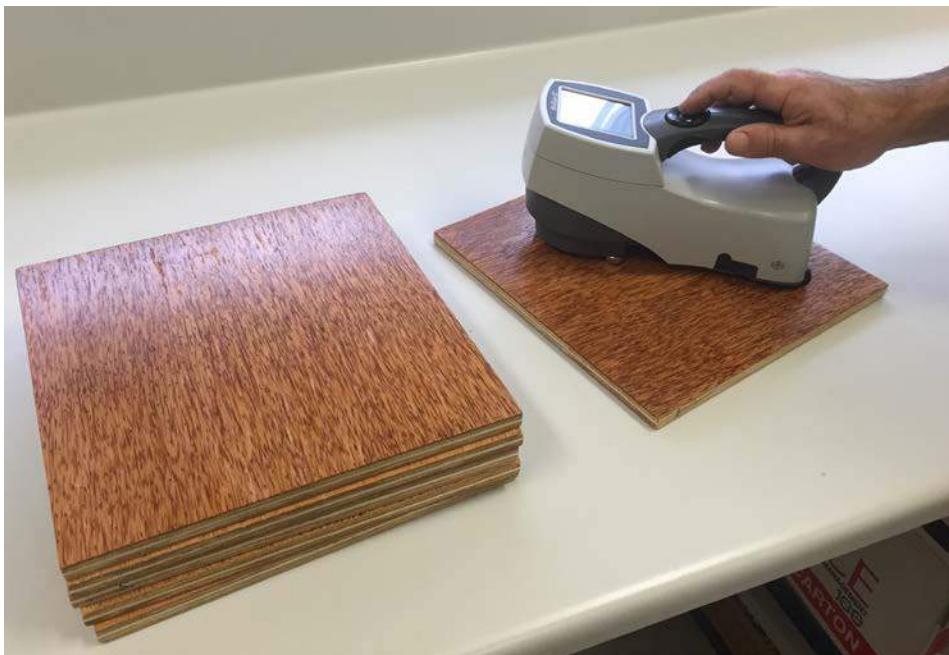
The veneer colour was measured using a portable spectro colorimeter. This instrument uses a xenon flash lamp to illuminate the sample. The reflected light is then separated in its components and expressed in the Commission Internationale d'Eclairage (CIE) L*a*b*-scale (also called CIELAB). This scale is an expression of a three dimensional measurement with an L*-value (100 = perfect white, 0 = black), a*-value (describes redness when positive, grey when zero and greenness when negative) and b*-value (describes yellowness when positive, grey when zero and blueness when negative).

Image 7 – Colour measurement on cocoveneer

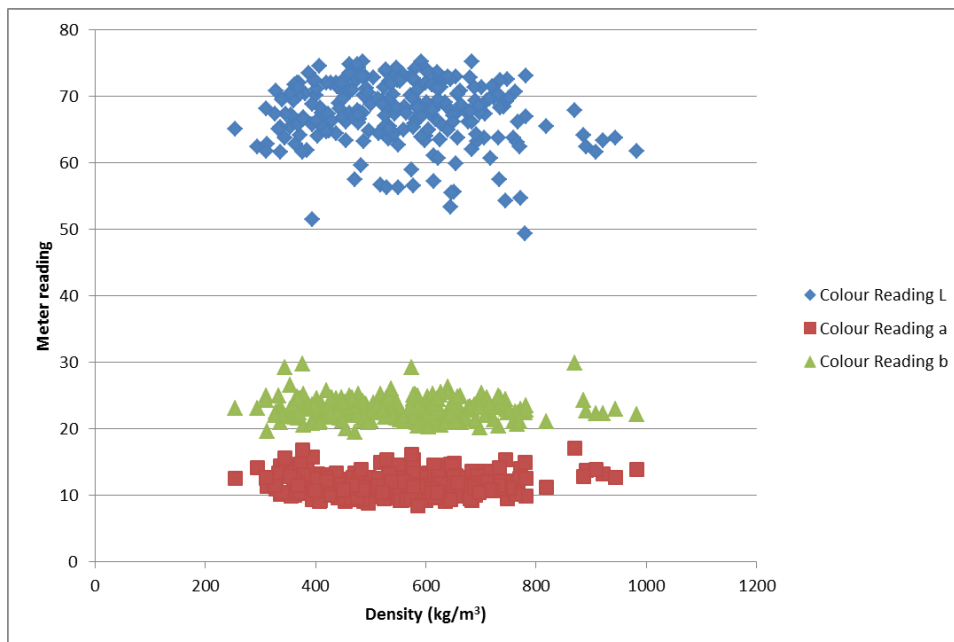
The colour measurements suggest the veneers from the trial contained minimal variation in colour and very little change in colour with increasing density (Fig. 1). These findings provide further support that colour is a limited indicator for density and could not be used in isolation as a grading method for separating veneer densities.

Figure 1 – Cocoveneer colour assessment.

Note: L*=darkness/brightness, a*=redness/greenness, b*=yellowness/blueness

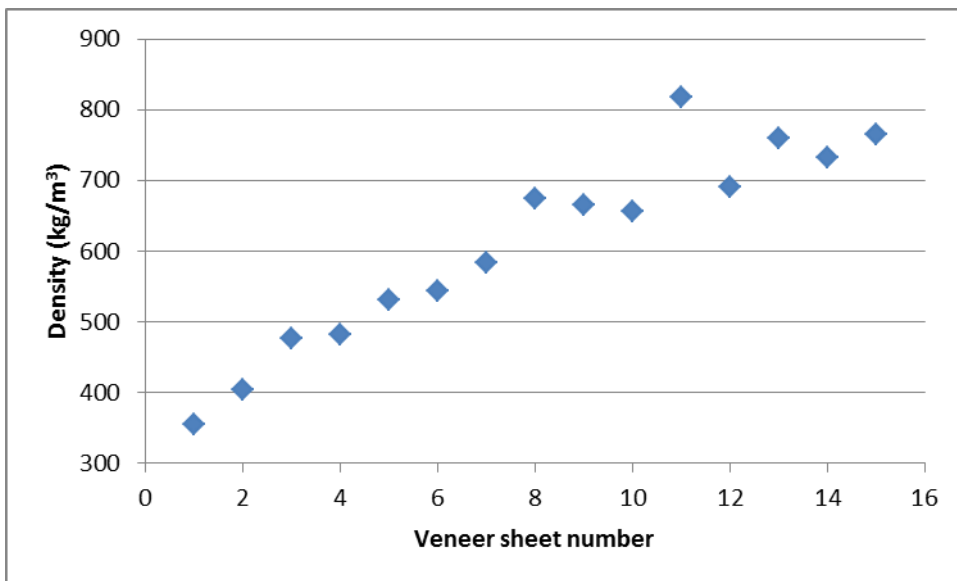
As expected, the density increased from the veneer recovered from towards the centre of the log to the veneers recovered from the periphery of the log. Fig. 3 displays an example of the veneer sheet density trend produced from one log. The veneer sheet numbering in this example starts from the veneer from the inner part of the log and finishes at the sheet recovered from the log periphery. The range in density that exists within a coconut log is potentially two to three times more than what would be experienced in traditional wood resources and highlights one of the challenges with utilising the coconut resource. The wide range of densities will certainly have implications for pre-conditioning, processing, veneer quality segregation systems and target product manufacture.

Figure 3 – Example of density radial variation from the centre to the outside of a coconut log

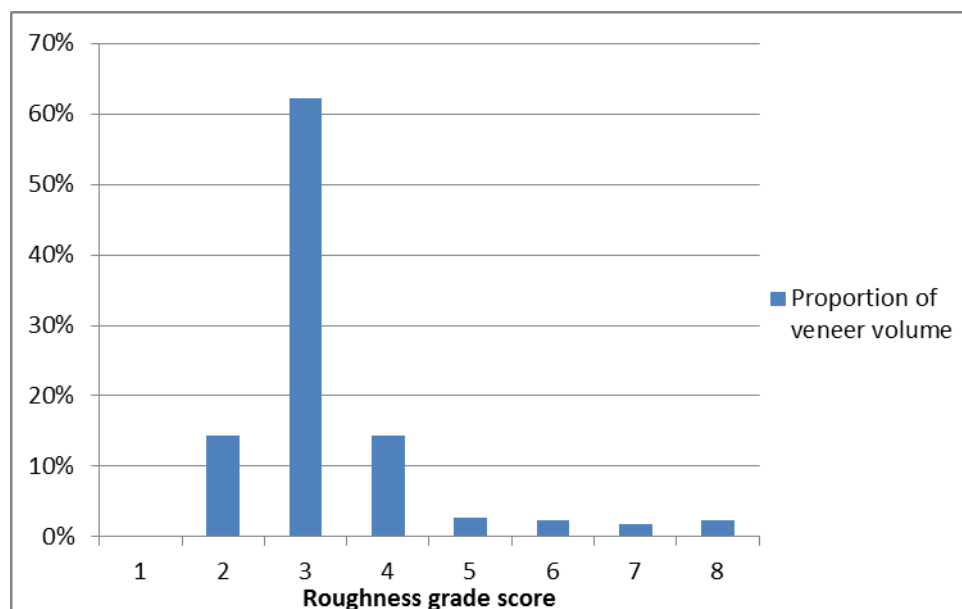
The trial veneer produced a wide range of veneer roughness qualities however no veneer was considered 'smooth' (score 1) (Fig. 4). A roughness score of 3 dominated the assessment indicating that the veneers would be expected to be made smooth after moderate sanding. While sanding may provide a potential solution, this process can usually only be performed practically on the final product meaning the roughness must be managed through the manufacturing process. Roughness can be particularly challenging for achieving reliable and efficient glue bonds during product manufacture.

Figure 4 – Distribution of veneer roughness scores

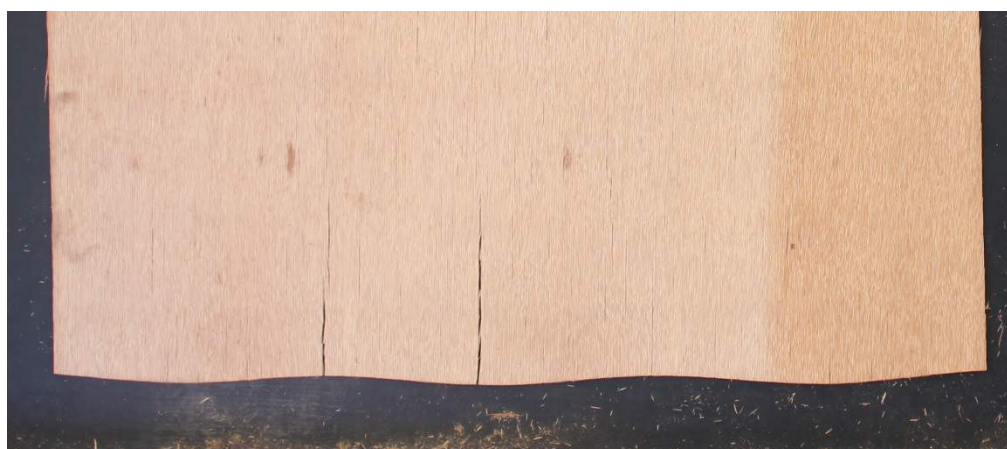
This assessment focused on splits that were believed to be a result of veneer compression, shrinkage or other stress releases (Image 8). Splits believed to have resulted from handling were not included in this assessment (see section 3.11) although it is acknowledged that accurately identifying the source of the splits is difficult. Figure 5 displays the distribution of split grade scores. Over half of the veneer produced during the trial scored 3 or higher. Splits can have quite negative implications for the successful manufacture of end products, particularly those which demand high aesthetic qualities. Correct log pre-conditioning temperatures followed by optimised lathe settings would be expected to contribute to the most gains in reducing splits.

Image 8 – Example of veneer splits

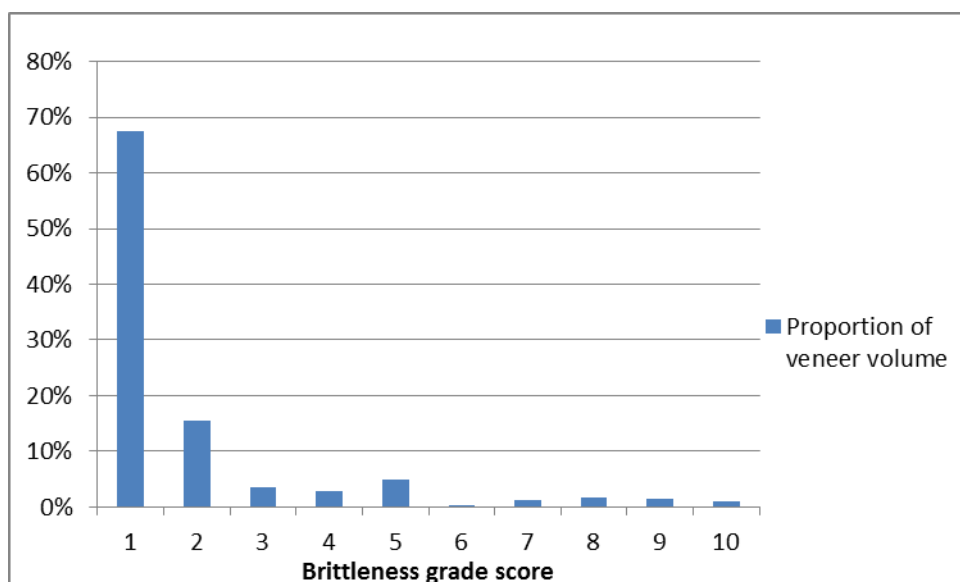
The brittleness of veneer can make handling during stacking, drying and grading difficult. Brittleness can also negatively impact the utilisation of the veneer during product manufacture. Just under 70% of the veneer was assessed to have acceptable brittleness (Fig. 6 and Image 9). A positive but weak correlation exists between brittleness score and veneer density ($r^2 = 0.34$) confirming brittleness will be more problematic as the higher density target resource is peeled. Correct log pre-conditioning temperatures followed by optimised lathe settings would be expected to reduce veneer brittleness. The unique structure of coconut palm may also demand non-traditional target veneer thickness to assist in minimising brittleness. Efforts to reduce this particular defect should be a primary focus of future processing trials.

Figure 6 – Distribution of brittleness scores

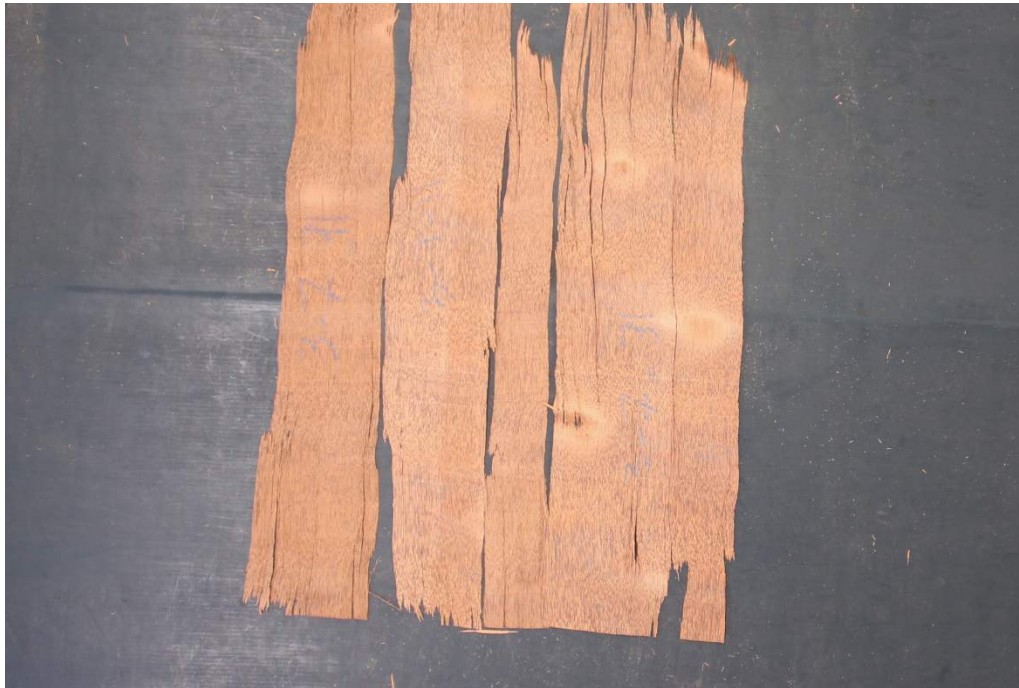
Image 9 – Example of poor quality and split veneer due to brittleness

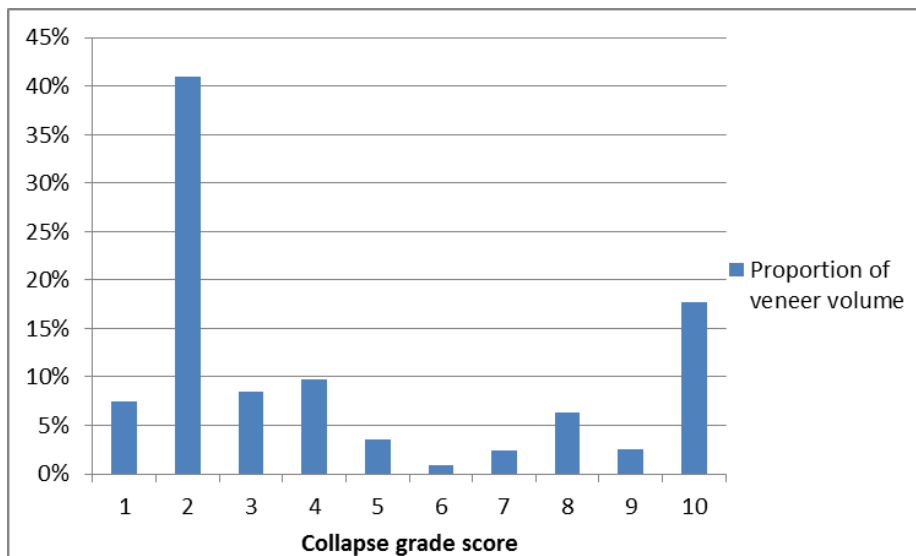
As illustrated within Fig. 7, many of the veneers contained collapse resulting in the veneer surface being fractured and split. The final implications of this defect will be dependent on the final product application, however it would be expected that the severity and frequency of collapse would need to be improved substantially from that displayed in the trial veneer. Correct log pre-conditioning temperatures followed by optimised lathe settings would be expected to contribute to the most gains in reducing collapse in cocoveneer. Efforts to reduce this particular defect should be a primary focus of future processing trials.

Figure 7 – Distribution of collapse scores

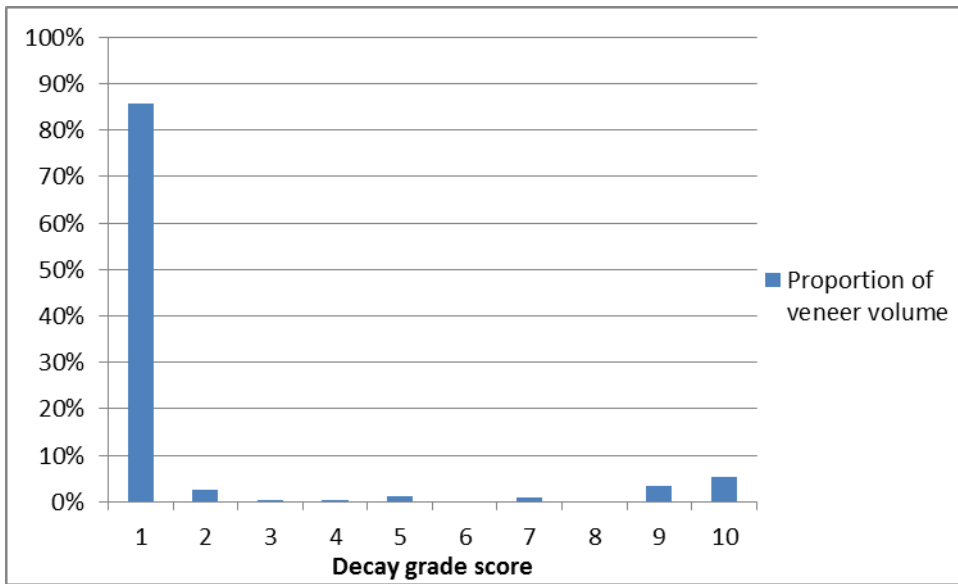
Decay was present in 14% of veneer suggesting that either decay was present in the standing palm and/or the delay between harvesting and processing was sufficient for decay to establish (Fig. 8 and Image 11). Any management strategy to reduce the presence of decay in cocoveneer can only be made as part of palm selection, harvesting and/or log storage procedures.

Figure 8 – Distribution of decay scores

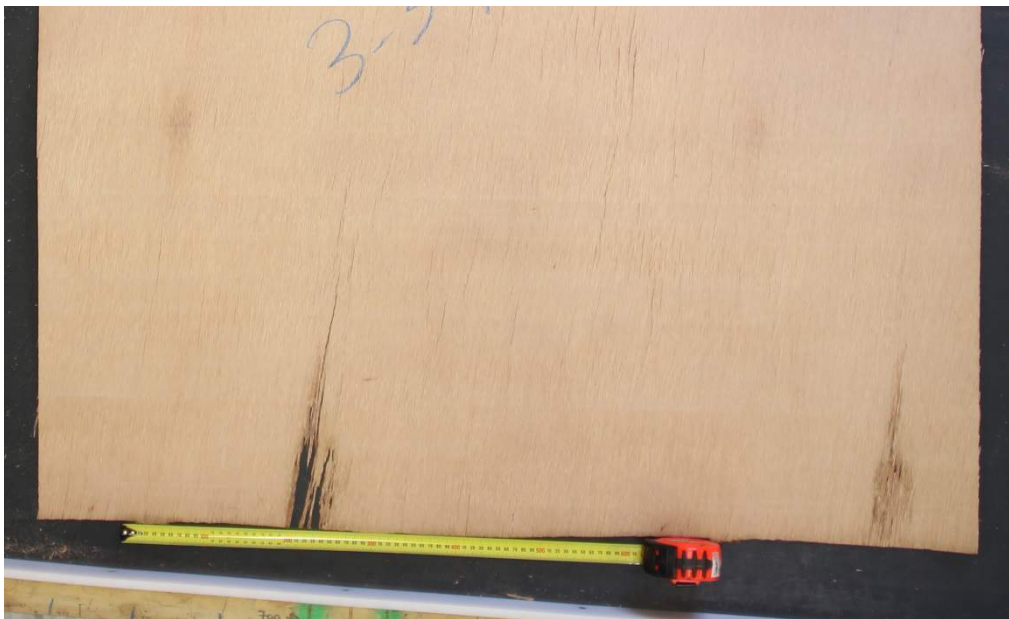
Image 11 – Example of decay in veneer

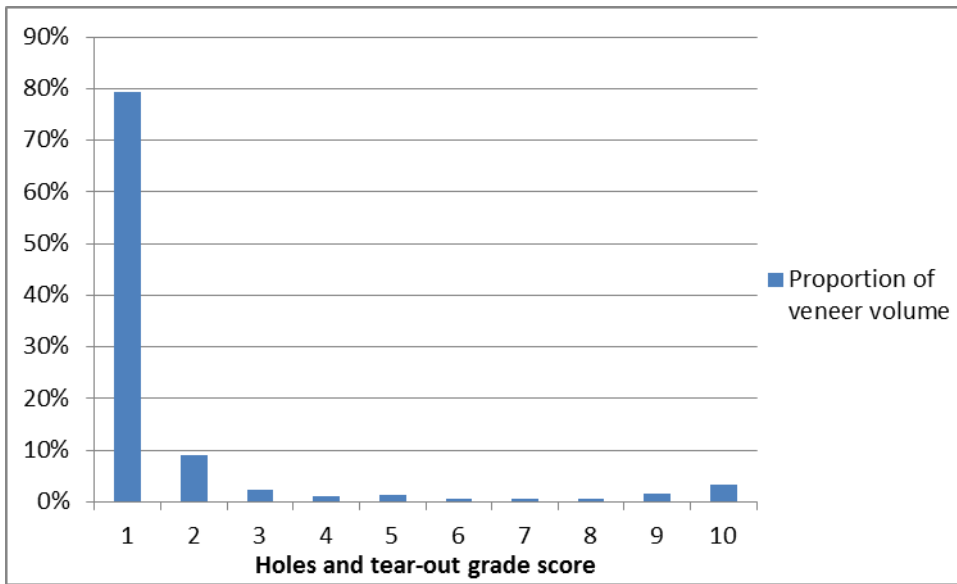
The presence of holes and tear-out negatively affected just over 20% of trial veneer (Fig. 9 and Image 12). The cause of this defect could be influenced by a range of factors including decay, undersized thickness and mechanical damage on the log. Many of the causes of this defect would be expected to be relatively easily managed through optimised processing protocols and log quality control systems.

Figure 9 – Distribution of holes and tear-out scores

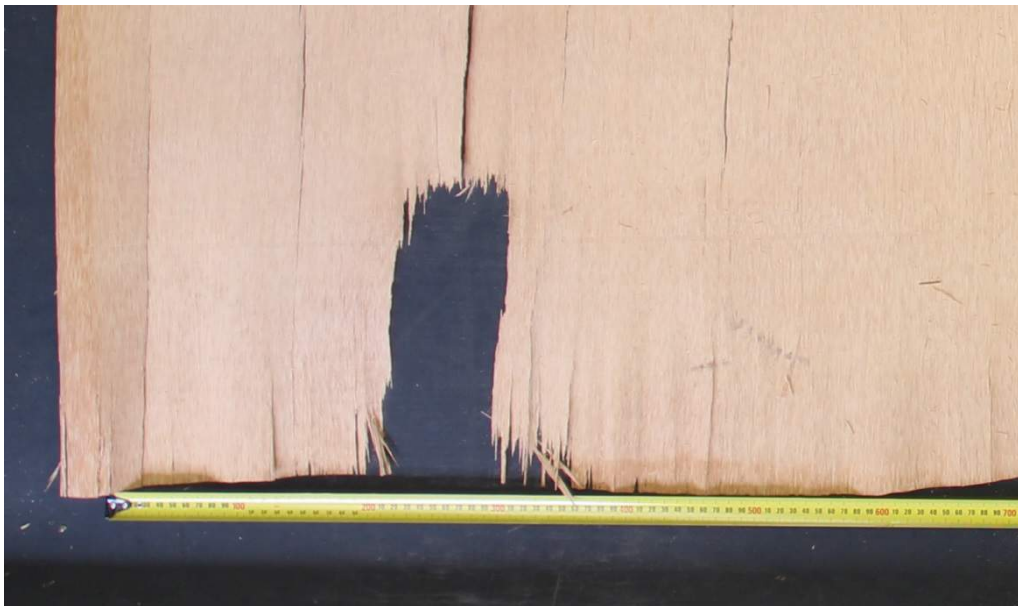
Image 12 – Example of tear-out in veneer

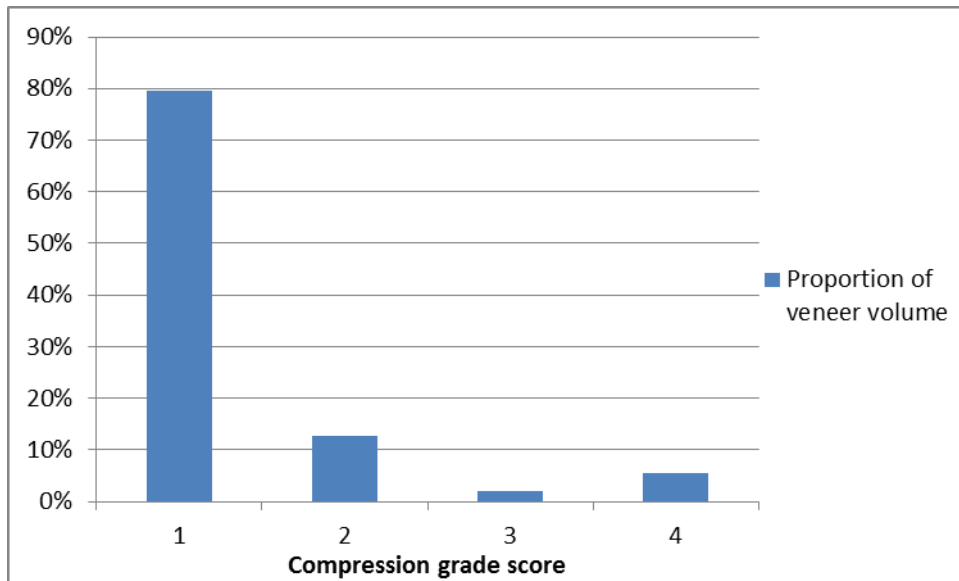
The occurrence of compression in veneer is quickly identified by the level of flatness or waviness of the veneer. In its most severe form, the veneer waviness prevents the veneer from being able to be pressed flat during product manufacture and reduces the effectiveness of the glue bond during pressing. The causes of compression can be resource-related (e.g. wavy grain) or process induced (e.g. poor log pre-conditioning and/or incorrect lathe settings). There was some degree of compression in approximately 20% of veneers (Fig. 10).

Figure 10 – Distribution of compression scores

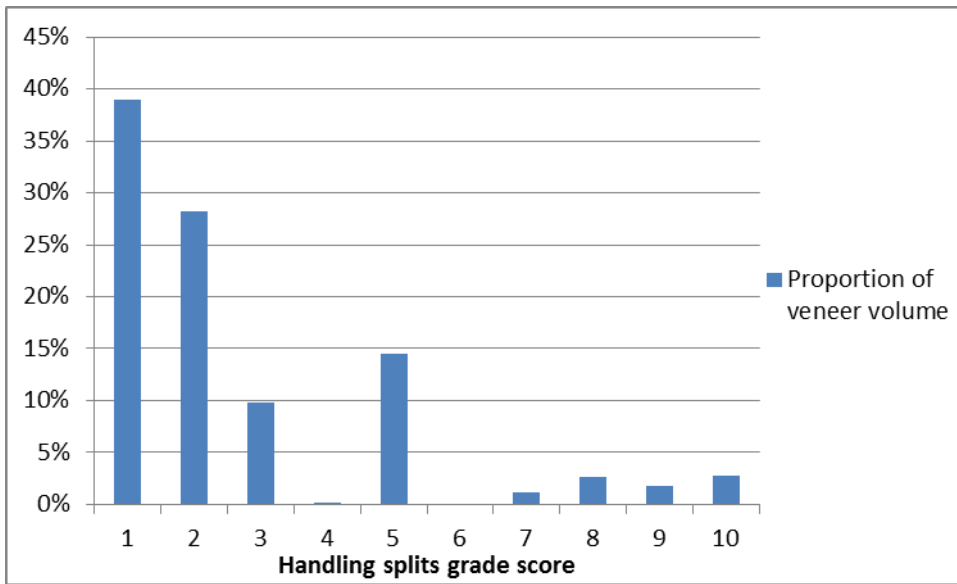
Over 60% of the trial veneers were affected by handling splits (Fig. 11 and Image 13). Optimised processing and veneer handling protocols would be expected to contribute to the most gains in reducing handling splits. While not the only cause of handling splits, handling veneers from the out feed of the clipper to veneer stacks was a source of many splits. Improvements in infrastructure and handling protocols in this area should be a priority for future trials.

Figure 11 – Distribution of handling splits scores

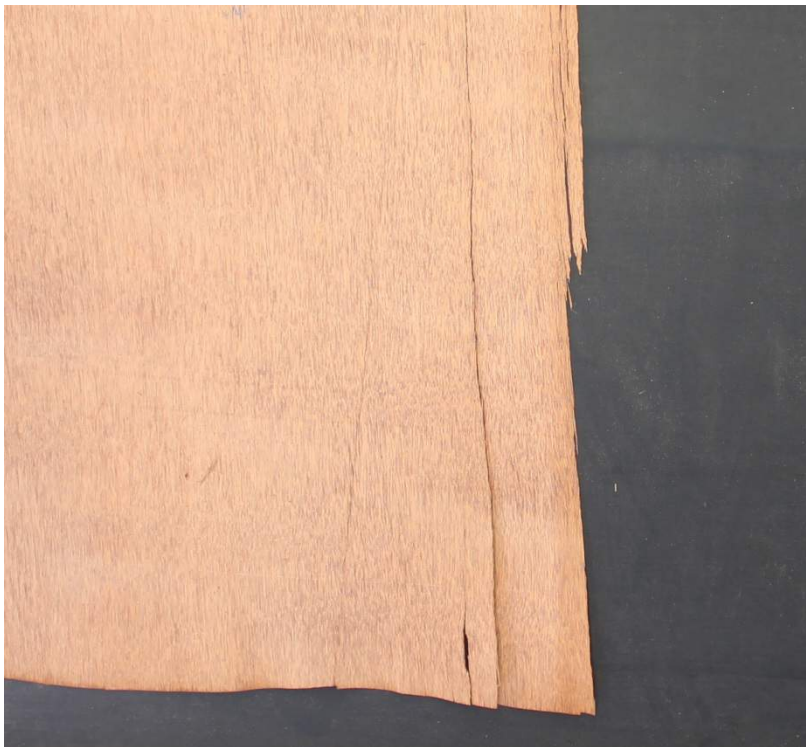
Image 13 – Example of handling splits

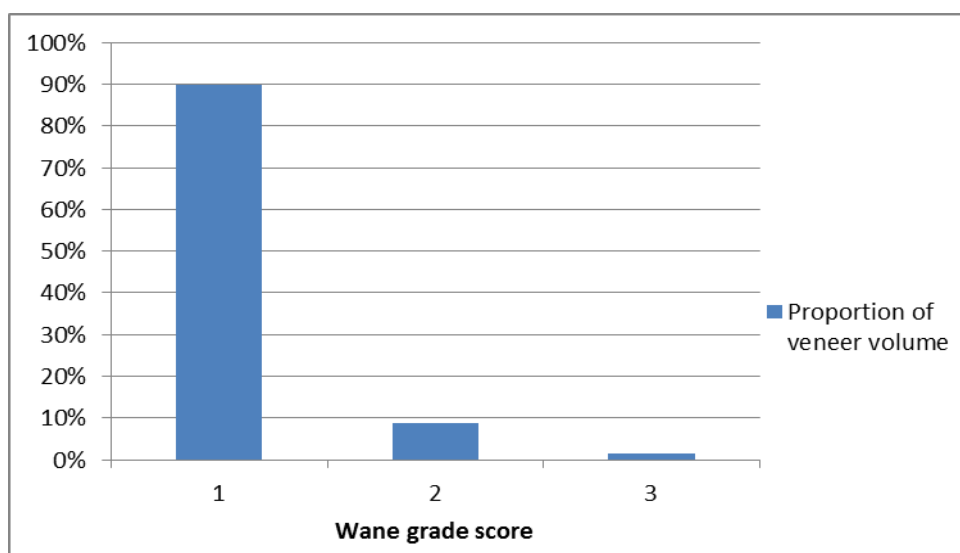
Wane on veneer is a direct result of insufficient log rounding before veneer is recovered meaning that sections of the log's natural edge remain in the veneer. Management of this defect is often a balance between maximising the recovery of veneer versus maximising the grade recovery from the peeled veneer volume. Wane will increasingly affect recovery and veneer quality as the log quality is reduced (i.e. sweep, taper and ovality increase). Of the veneer produced during the trial, 90% contained no wane, 9% contained small quantities considered manageable for product manufacture and only 1% of veneers contained wane severe enough to require rejection or major trimming before being considered usable (Fig. 12 and Image 14).

Figure 12 – Distribution of wane scores

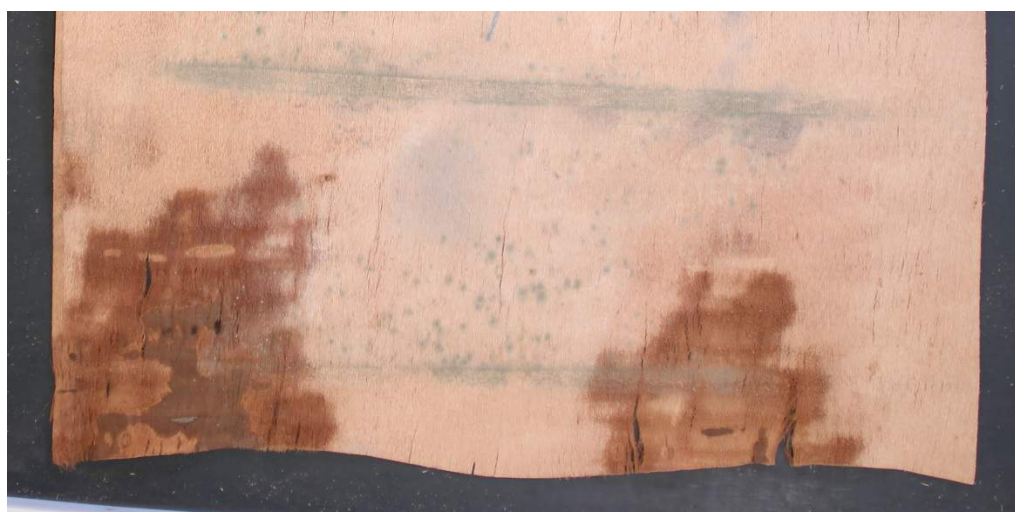
Image 14 – Example of wane in cocoveneer

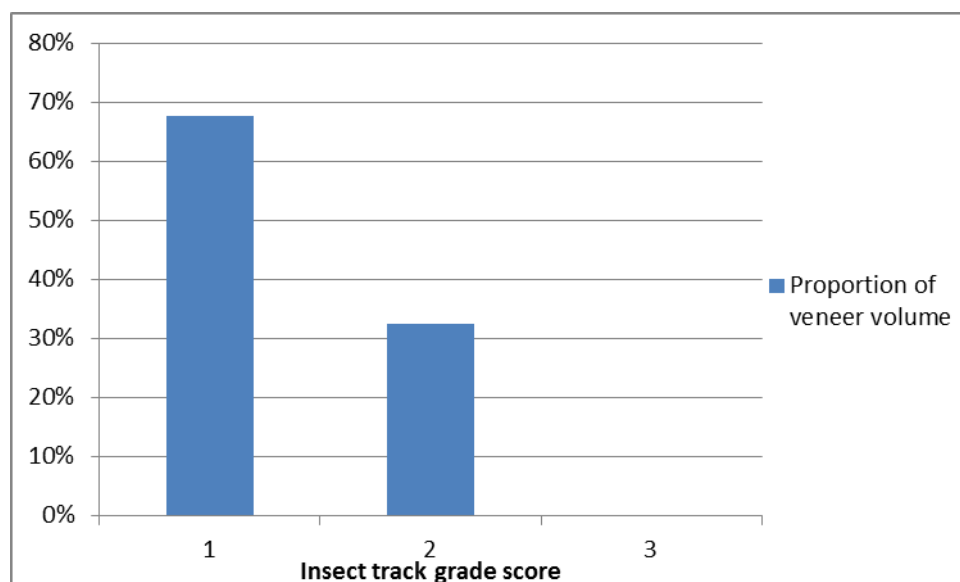
Insect tracks were identified on 32% of veneers, however the size and frequency were noted as being small (Fig. 13). The impact of insect tracks on veneer usability (and value) would be very dependent on the target end product.

Figure 13 – Distribution of insect track scores

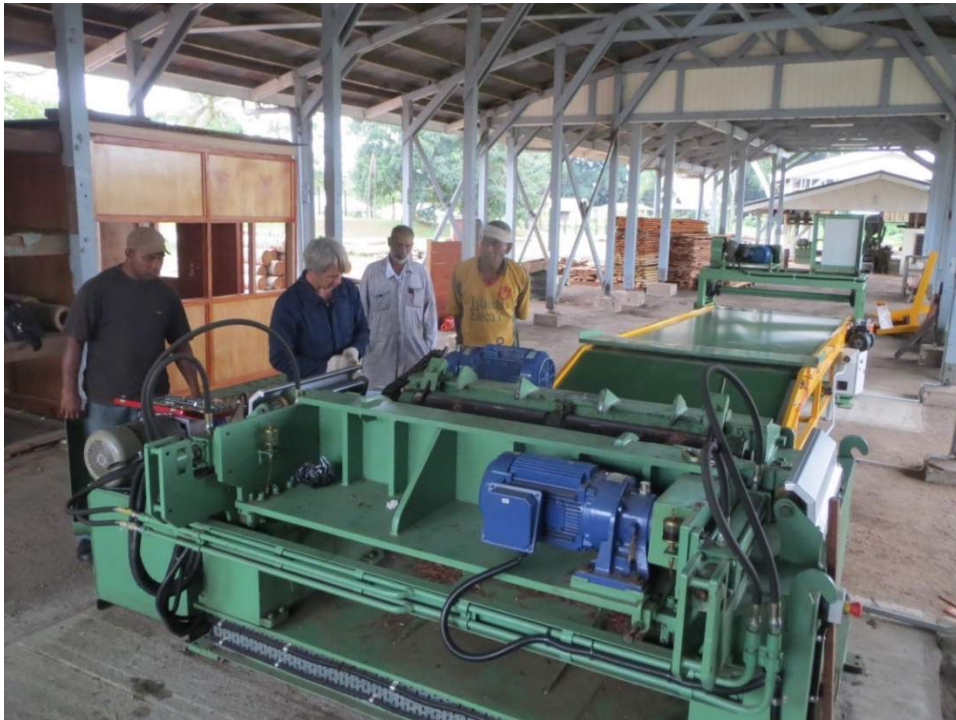
Introductory training in spindleless rotary veneer lathe setup, basic operation and lathe maintenance was provided to key operational and technical staff of TUD and SPC (Image 15). In addition, introductory training in veneer management techniques and veneer R&D data collection protocols (e.g. veneer labelling and thickness assessment), along with wood drying fundamentals and kiln operation was provided

Image 15 – Introductory training provided in veneer lathe setup
