ACIAR FST/2009/062 Development of advanced veneer and other products from coconut wood to enhance livelihoods in South Pacific communities

DAF Report - Coconut palm stem veneer processing

Trial 4

March 2016

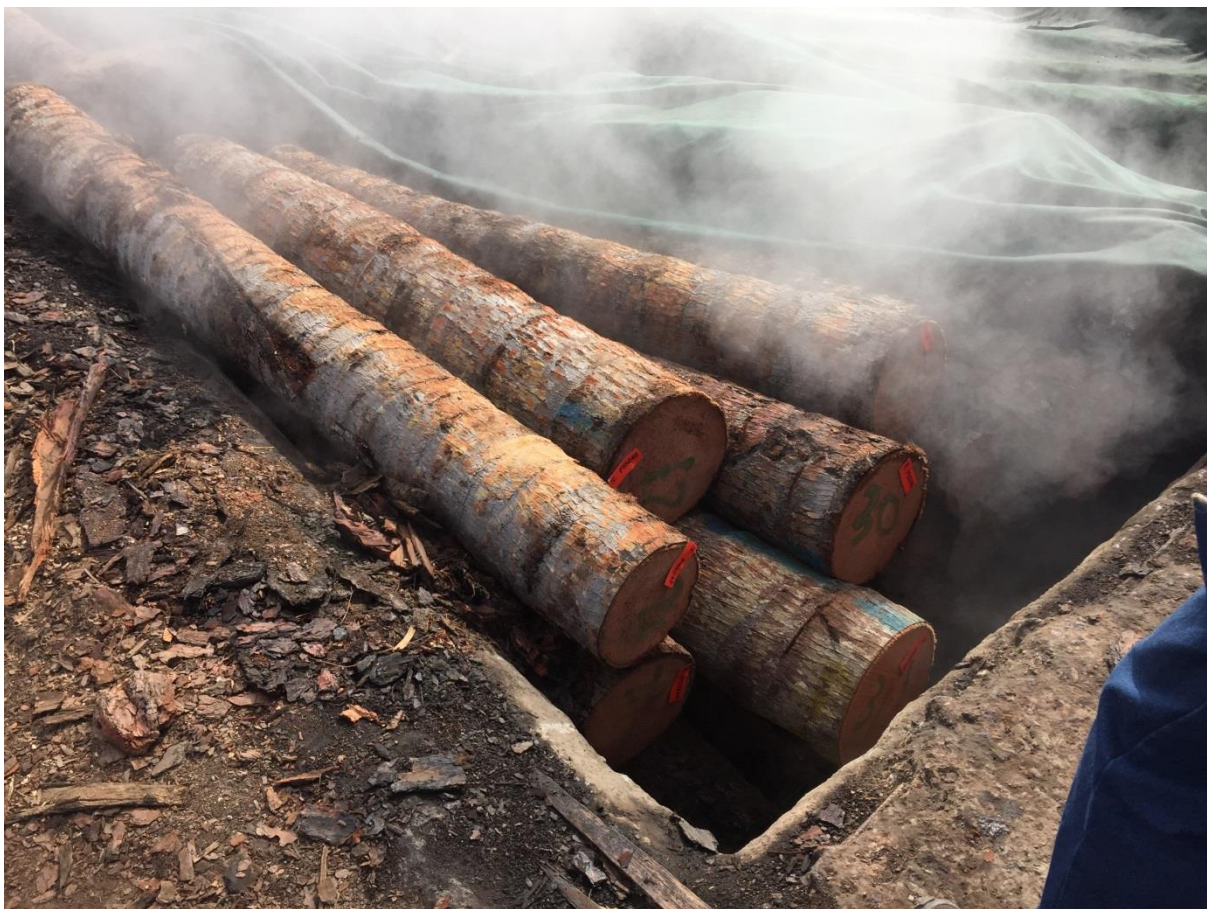
Image 1 – Water-steam chamber used to pre-condition coconut palm stem logs prior to peeling

Prior to pre-conditioning, logs were docked to provide two billets for peeling that measured approximately 2700 mm in length. Pre-conditioning was performed in a water-steam chamber and targeted core log temperatures of around 80-90 degrees Celsius (Image 1). The pre-conditioning process aims to soften the billet to improve the peeling operation and the resulting veneer quality (McGavin *et al.* 2015). The requirements of pre-conditioning coconut palm stems prior to rotary peeling have been demonstrated in earlier processing trials (Bailleres *et al.* 2015, McGavin 2015) with temperatures above 80 degrees Celsius being necessary to gain the most benefit which includes reducing lathe cutting forces and improving veneer quality.

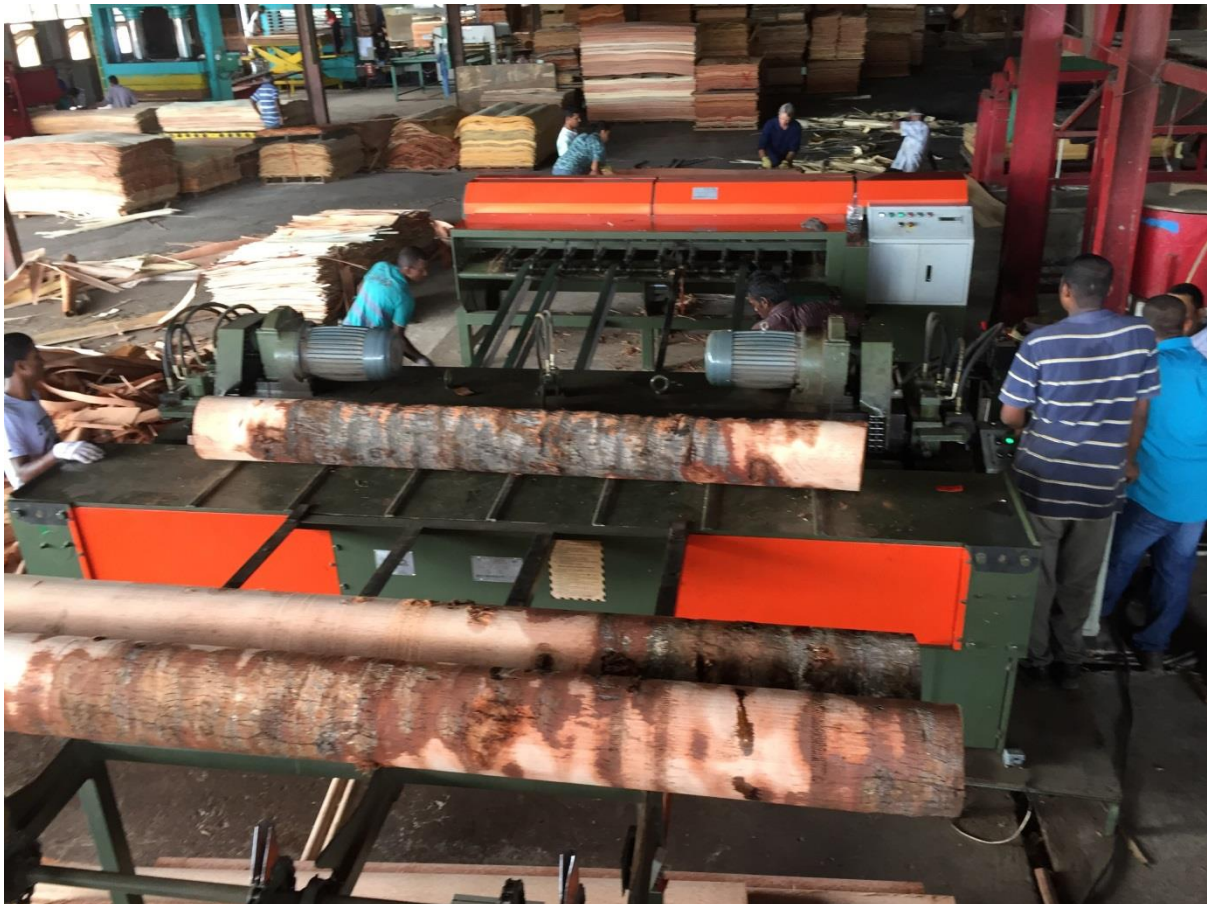
Image 2 – Spindleless veneer lathe used for peeling coconut stems

Rotary peeling was performed using a Chinese-built spindleless veneer lathe (Image 2). While the VTB staff had substantial knowledge and experience with lathe settings for commercial timber species, they had no experience with settings suited to coconut palm peeling. DAF experience in spindleless lathe operation combined with the learnings from previous project processing trials provided the base line initial settings and guided subsequent changes. The minimum residual or peeler core size was approximately 48 mm.

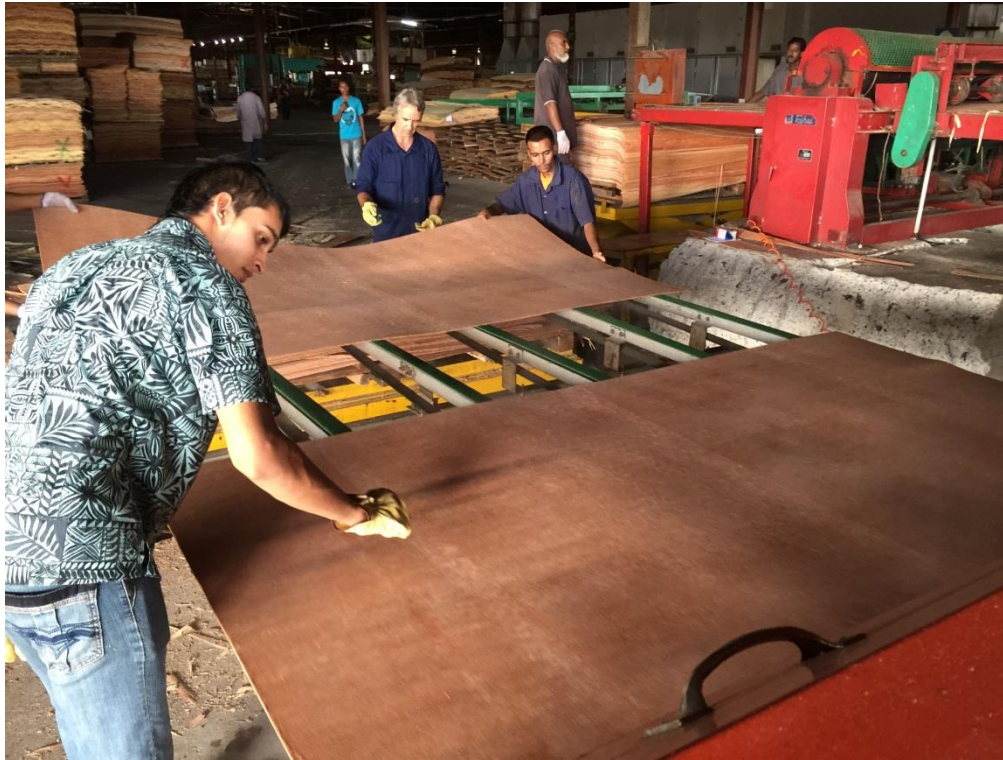
Image 3 – Veneer sheets were labelled with an individual identifier immediately after clipping

Peeled veneer was clipped targeting a sheet width of approximately 1,350 mm. Each veneer sheet was labelled with a unique identifier before being prepared for drying (Image 3). Veneer was dried using a commercial jet box drier using a modified drying schedule (Image 4). A target dry veneer moisture content of 6% was selected (Image 5). Dried veneers were packaged and forwarded to the DAF Salisbury Research Facility in Brisbane, Australia for further assessment.

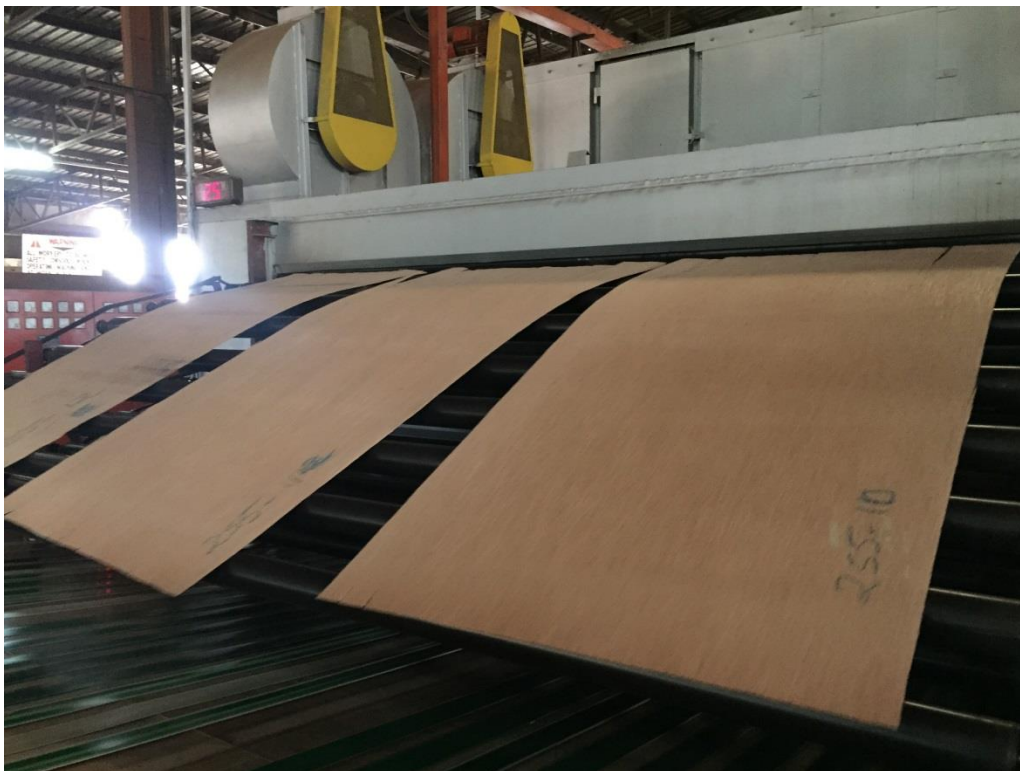
Image 4 – Cocoveneer sheets exiting the jet box drier

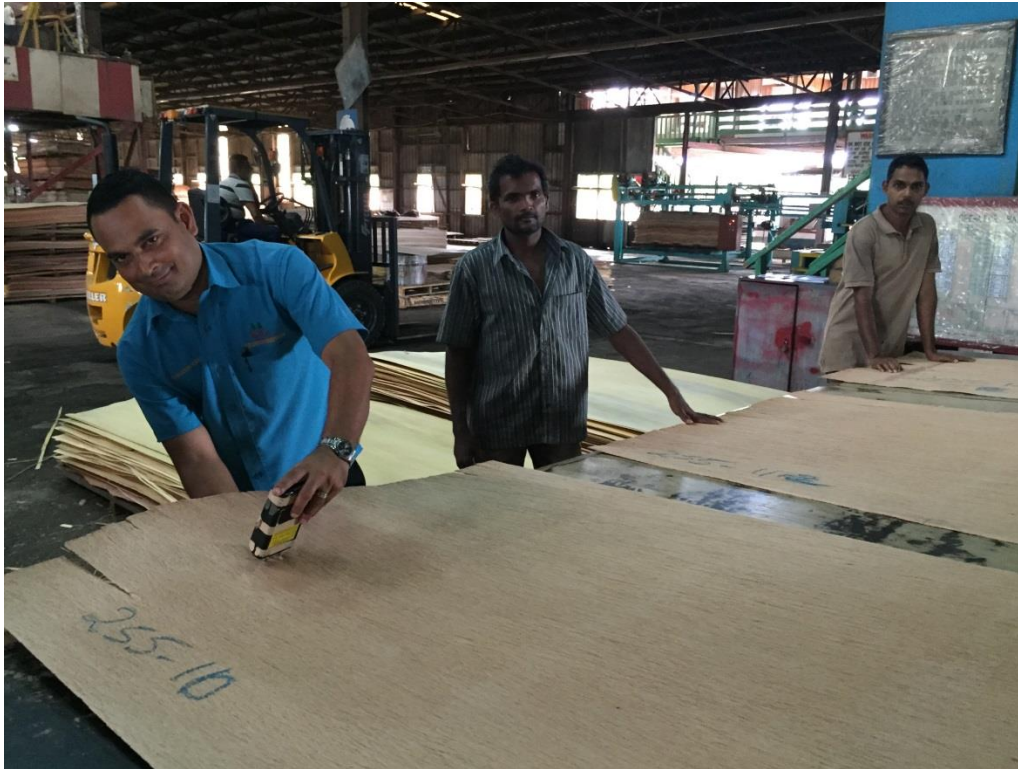
Image 5 – Checking cocoveneer moisture content at the completion of drying.

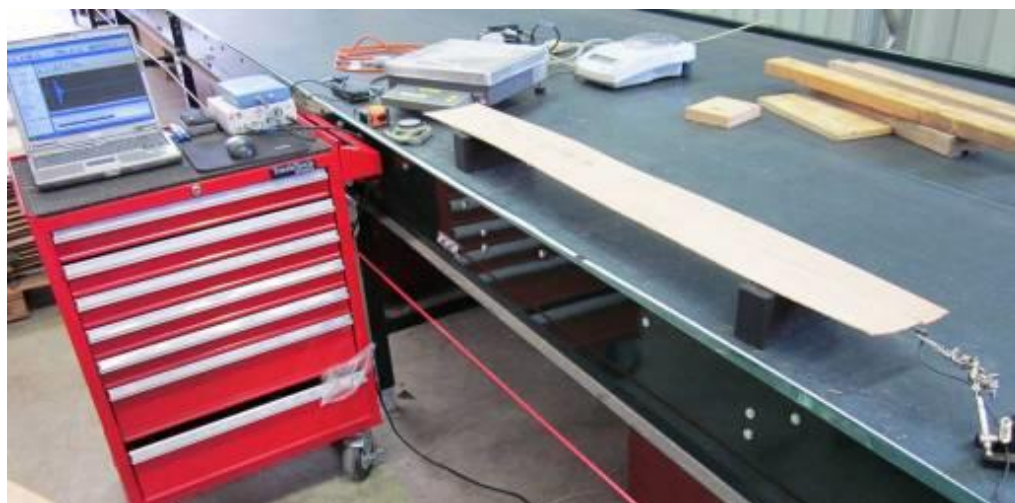
Image 6 – Modulus of elasticity measurement on cocoveneer sampling strips.

A sampling strip was removed from the veneer sheets used for grading to measure veneer modulus of elasticity (MoE). This same sampling strip was used to measure veneer density (see 2.3.1). Veneer MoE was measured using an acoustic natural-vibration method as described by Brancheriau and Bailleres (2002) (Image 6).

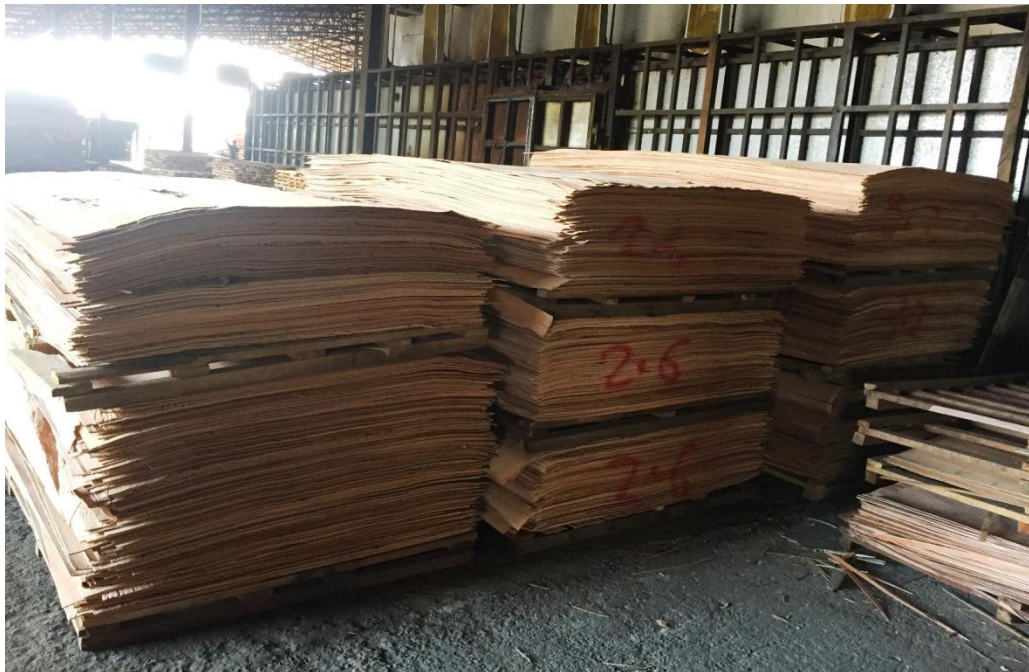
Image 7 – Cocoveneer produced during the trial

After drying, 12.5 m³ of veneer (Image 7) was recovered reflecting a recovery rate of 49.8% (or 65.0% of rounded billet volume). This is similar to the recovery reported during trial 3 despite the difference in lathe capacity (i.e. 1300 mm lathe for trial 3 and 2600 mm for trial 4). When a trimming factor is applied (similar to that reported by McGavin *et al.* 2014) to determine the volume of veneer recovered at a nominal standard length and width (edges trimmed square etc.), 11.4m³ of veneer was recovered reflecting a recovery rate of 45.4%.

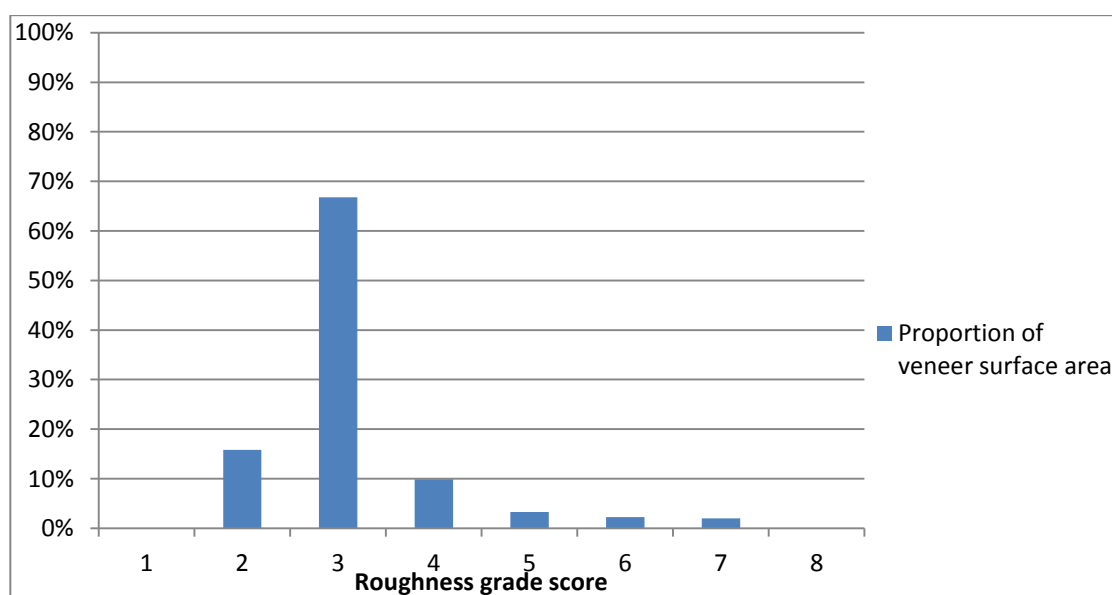
Figure 3 – Distribution of veneer roughness scores

The trial veneer produced a wide range of veneer roughness qualities with score distributions very similar to that reported for trial 3 (McGavin 2015). As per trial 3, no veneer was considered 'smooth' (score 1) and a roughness score of 3 dominated the assessment indicating that the veneers would be expected to be made smooth after moderate sanding (Fig. 3). While sanding may provide a potential solution, this process can usually only be performed practically on the final product meaning the roughness must be managed through the product manufacturing process. Excessive roughness can be particularly challenging for achieving reliable and efficient glue bonds during product manufacture.

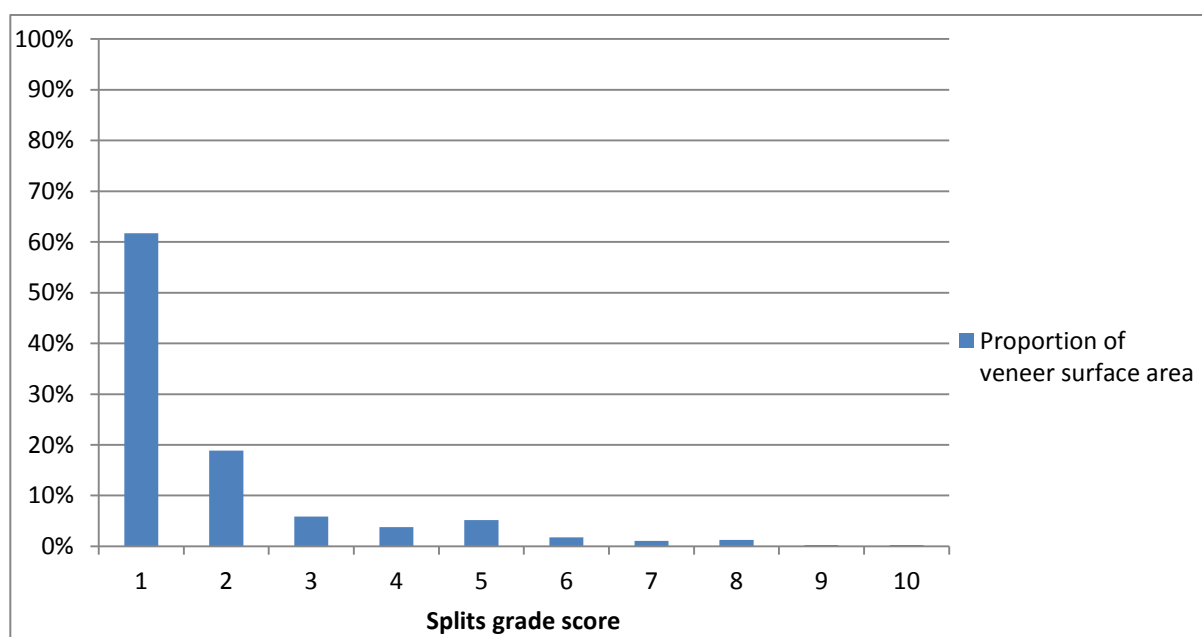
Figure 4 – Distribution of split scores

This assessment focused on splits that were believed to be a result of veneer compression, shrinkage or other stress releases (Image 8). Splits believed to have resulted from handling were not included in this assessment (see section 3.2.9) although it is acknowledged that accurately identifying the source of the splits is difficult. Figure 4 displays the distribution of split grade scores. Over 60% of the veneer produced during the trial achieved a split grade score of 1. This is a significant improvement from the results of trial 3 and is reflective of the improved protocols adopted during this trial, especially during drying. Splits can have quite negative implications for the successful manufacture of end products, particularly those which demand high aesthetic qualities.

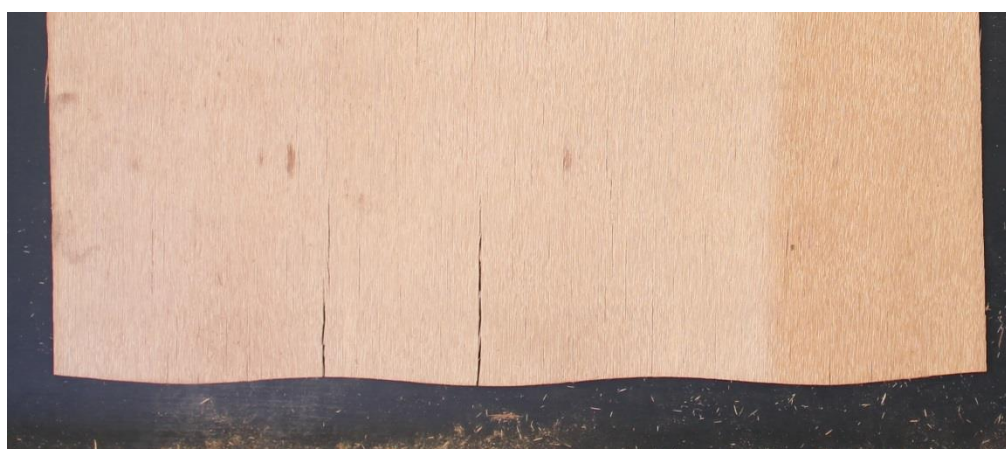
Image 8 – Example of veneer splits

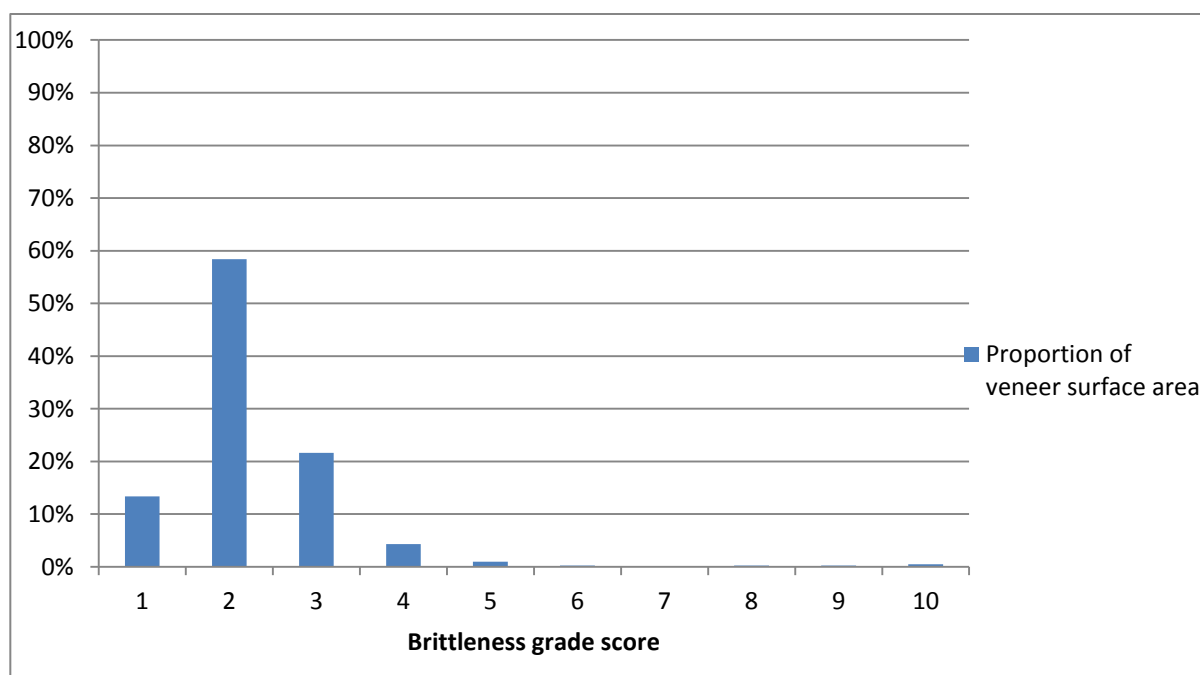
Figure 5 – Distribution of brittleness scores

Over 90% of the veneer recorded a brittleness grade score of 3 or better (Fig. 5). McGavin (2015) highlighted brittleness in processing trial 3 as a veneer characteristic requiring targeted improvement in future trials. As explained in section 2.2, a modified grading method was used to assess veneer brittleness compared to that reported by McGavin (2015) for processing trial 3. While this prevents a direct comparison to the previous trial, it is reasonable to note that the veneer brittleness was significantly improved in this trial. This is a direct result of improved processing protocols adopted during this trial.

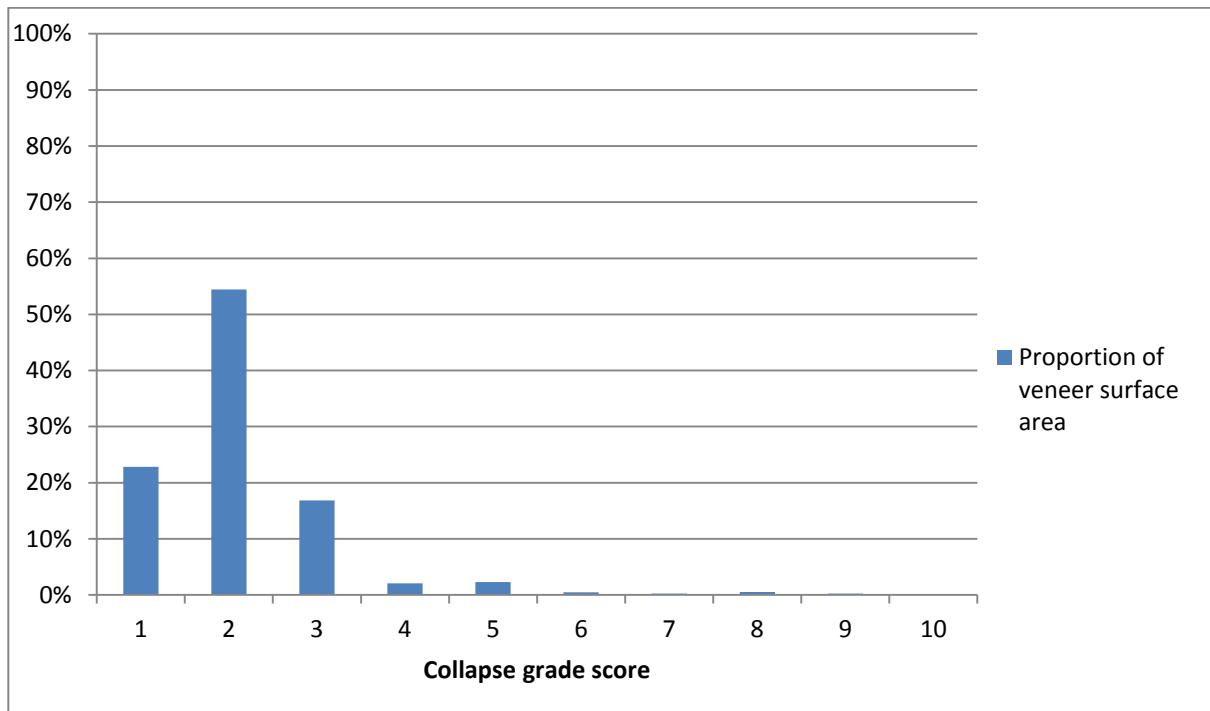
Figure 6 – Distribution of collapse scores

The severity of collapse in veneers from this trial was improved substantially compared to the veneers produced during trial 3. Over 90% of the veneers recorded a collapse grade score of 3 or better (Fig. 6). This is a significant improvement from the results of trial 3 where it was recommended that the reduction in this defect type be a primary focus of future trials. The improved result is reflective of the improved protocols adopted during this trial, especially during drying. Collapse can have quite negative implications for the successful manufacture of end products, particularly those which demand high aesthetic qualities.

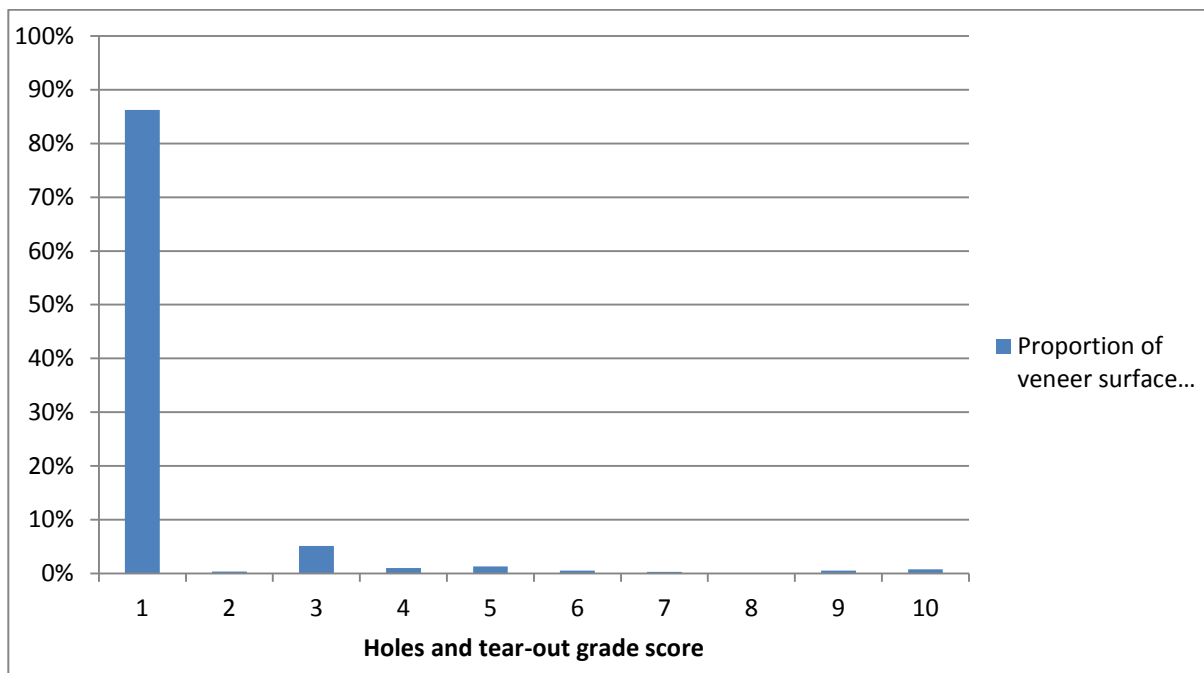
Figure 8 – Distribution of holes and tear-out scores

The severity of holes and tear-out in veneers from this trial was improved compared to the veneers produced during trial 3. The presence of holes and tear-out negatively affected 14% of trial veneer (Fig. 8) compared with over 20% in trial 3. The cause of this defect could be influenced by a range of factors including decay, undersized veneer thickness and mechanical damage on the log. Many of the causes of this defect would be expected to be relatively easily managed through optimised processing protocols and log quality control systems.

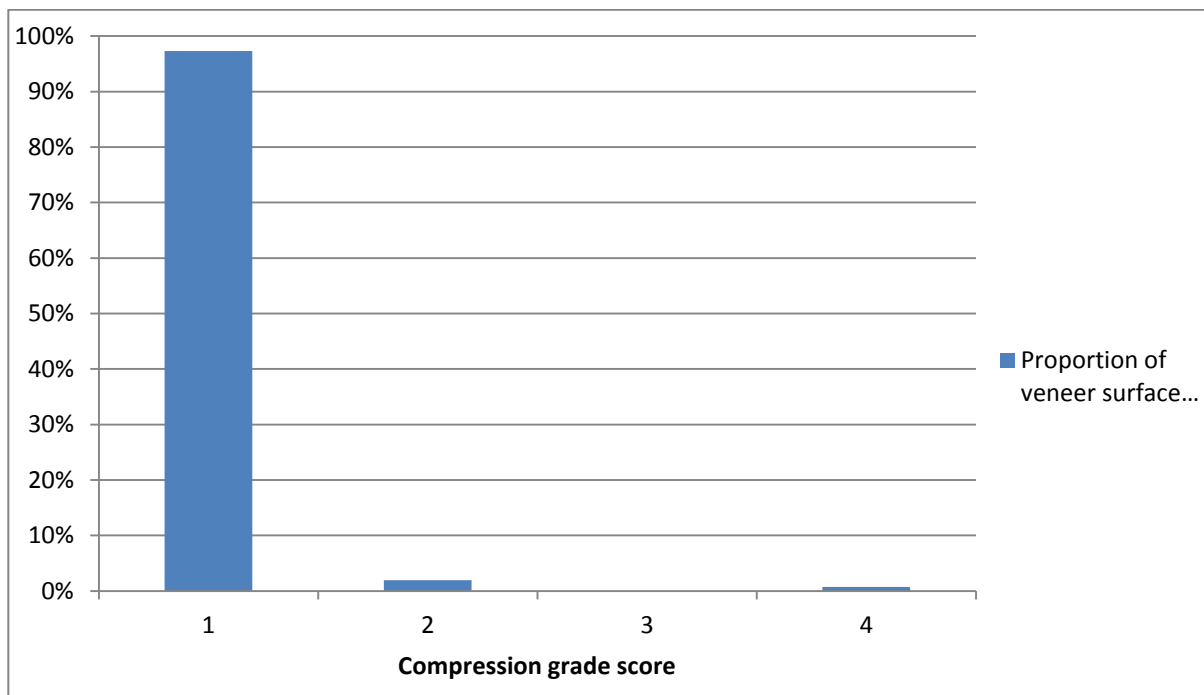
Figure 9 – Distribution of compression scores

The occurrence of compression in veneer is quickly identified by the level of flatness or waviness of the veneer. In its most severe form, the veneer waviness prevents the veneer from being able to be pressed flat during product manufacture and reduces the effectiveness of the glue bond during pressing. The causes of compression can be resource-related (e.g. reaction wood) or process induced (e.g. poor log pre-conditioning and/or incorrect lathe settings). Over 97% of the trial veneer achieved a grade score 1 for compression compared with trial 3 where less than 80% achieved a grade score of 1 (Fig. 9).

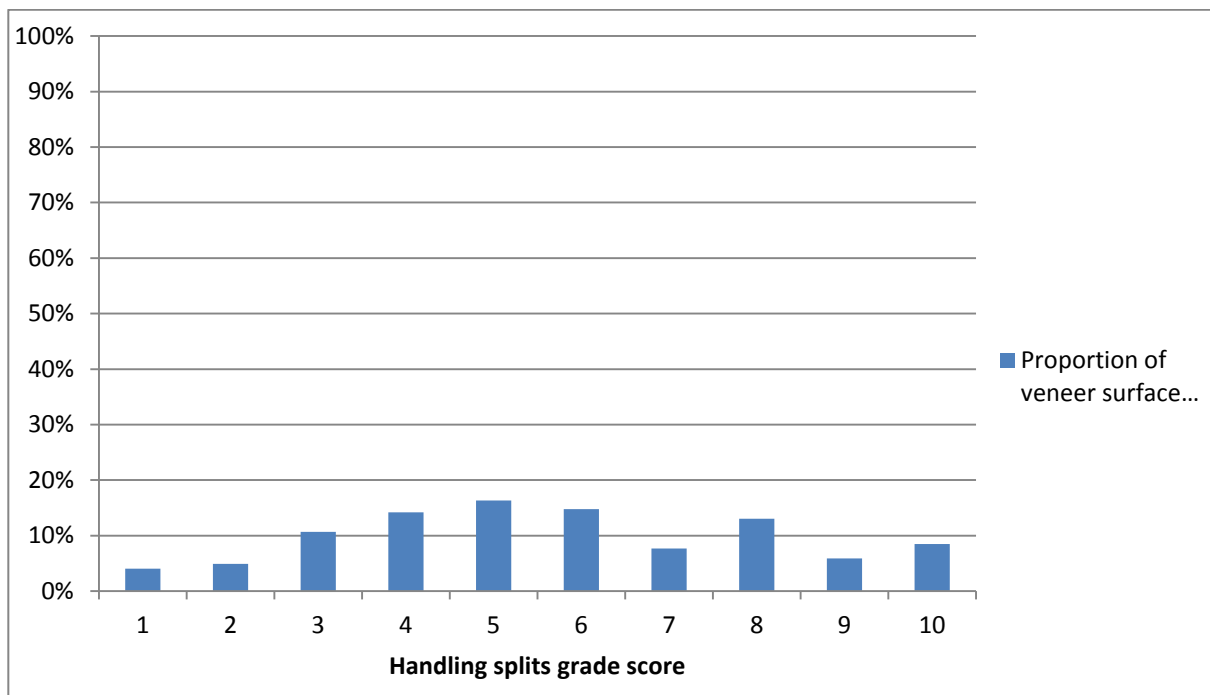
Figure 10 – Distribution of handling splits scores

The resulting spread of handling split grade scores are presented in Figure 10. As explained in section 2.2, a modified grading method was used to assess veneer handling splits compared to that reported by McGavin (2015) for processing trial 3. While this prevents a direct comparison to the previous trial, it is reasonable to note that the handling splits were significantly improved in this trial. This is a result of better veneer clipping and handling infrastructure and protocols adopted during this trial.

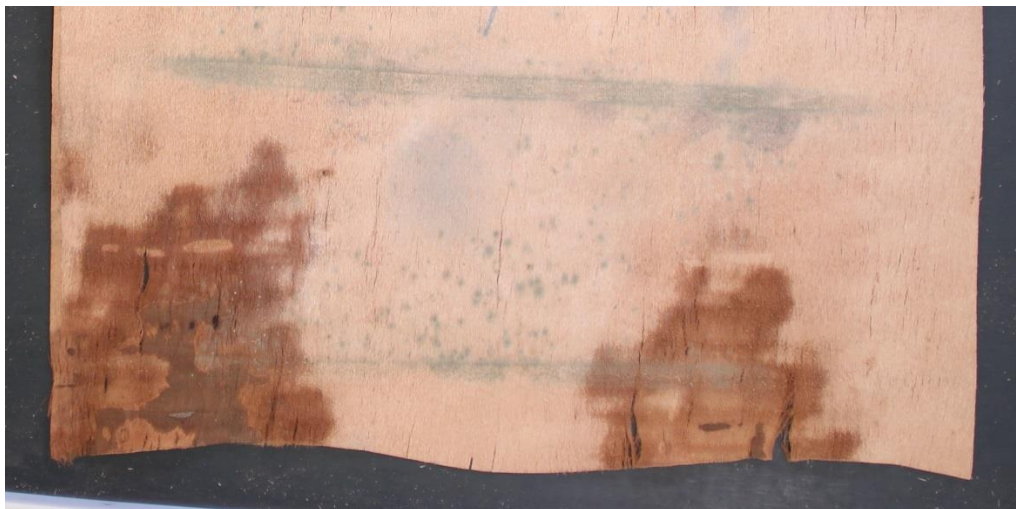
Image 9 – Example of wane in cocoveneer

Wane on veneer is a direct result of insufficient log rounding before veneer is recovered meaning that sections of the log’s natural edge remain in the veneer. Management of this defect is often a balance between maximising the recovery of veneer versus maximising the grade recovery from the peeled veneer volume. Wane will increasingly affect recovery and veneer quality as the log quality is reduced (i.e. sweep, taper and ovality increase). Of the veneer produced during the trial, 94% contained no wane, 4% contained small quantities considered manageable for product manufacture and only 2% of veneers contained wane severe enough to require rejection or major trimming of the veneer sheet before being considered usable (Fig. 11 and Image 9).

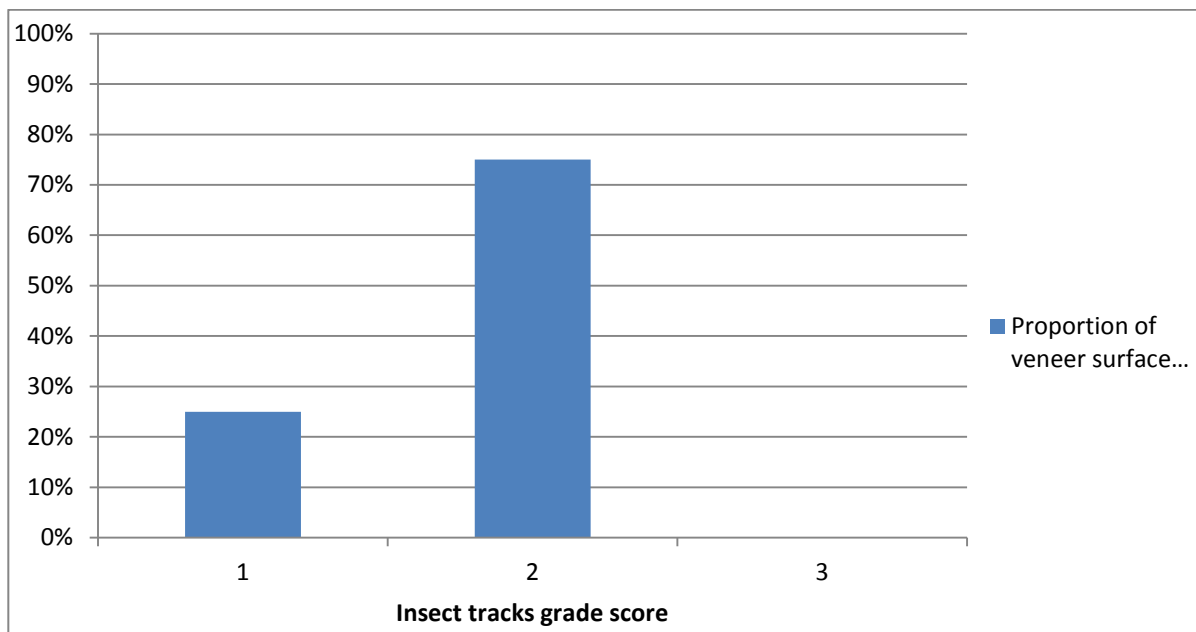
Figure 12 – Distribution of insect track scores

Insect tracks were identified on 75% of veneers (Fig. 12), however the size and frequency were noted as being small. This is a much higher presence than in trial 3 veneers where only 32% of veneers were noted to have insect tracks. The impact of insect tracks on veneer usability (and value) would be very dependent on the target end product.
