Experimental Investigation on Rotary Peeling Parameters of High Density Coconut Wood

Henri Bailleres,^{a,*} Louis Denaud,^b Jean-Claude Butaud,^b and Robert L. McGavin^a

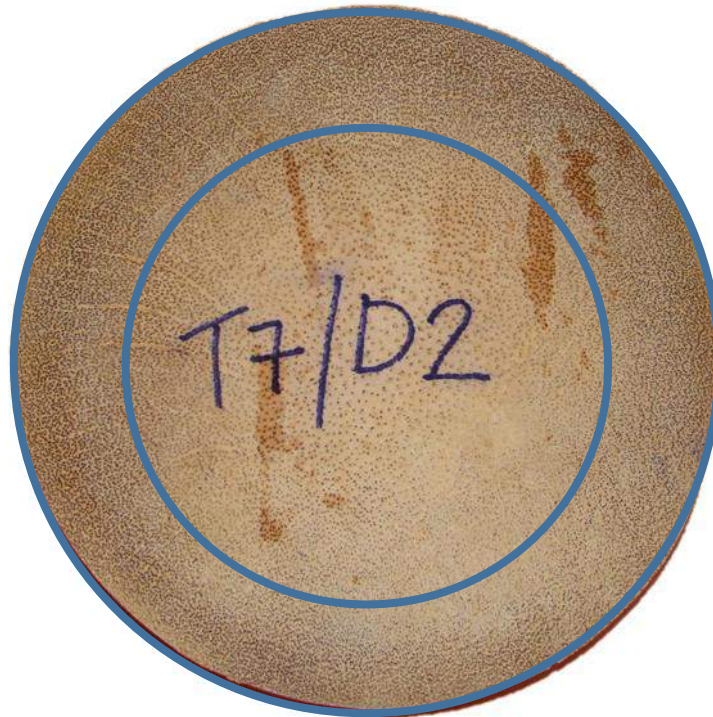
Fig. 1. Coconut disc with its specimen reference showing that the most valuable area for high density veneer production lies between the blue circles

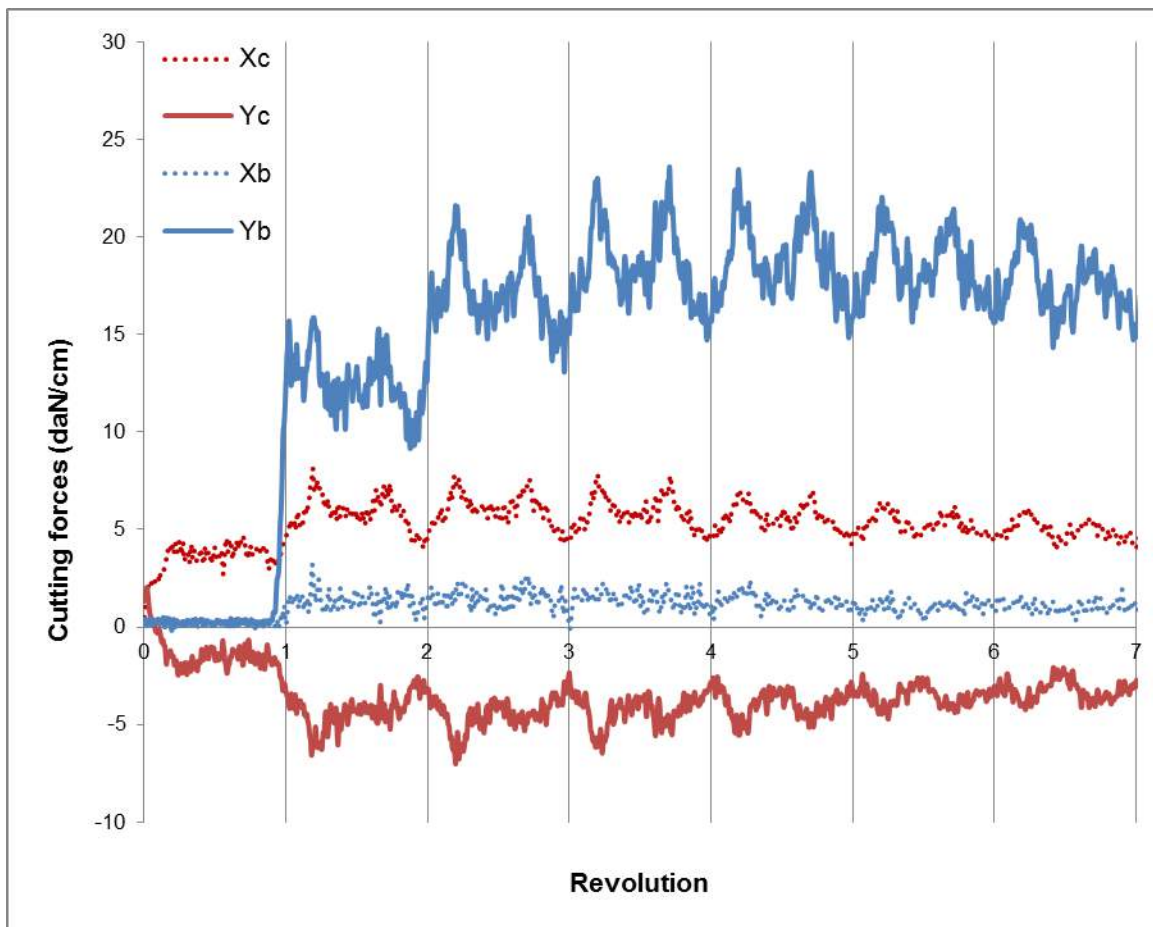
Fig. 5. Example cutting force data profile

For each lathe setup, the forces were measured according to the cutting plane in orthogonal directions, where X is the tangential axis and Y the radial axis for both tools (see Figs. 3 and 4). The measurements were recorded according to the methodology described by Butaud *et al.* (1995) and Marchal *et al.* (2009) in which X_c and Y_c were measured on the knife, and X_b and Y_b were measured on the pressure bar (Figs. 3 and 4). The forces exerted in the cutting plane, both on the pressure bar and the knife, were measured using piezoelectric load cells with the signal smoothed by a low-pass filter (50 Hz) prior to being sampled at 1000 Hz sampling frequency. The revolution angle was simultaneously recorded to obtain data as a function of the peeling revolution. To eliminate the impact of slight thickness variations between discs, the forces were expressed relative to the disc thickness (daN/cm). An example of the measurement and data extraction of the cutting forces is displayed in Fig. 5.

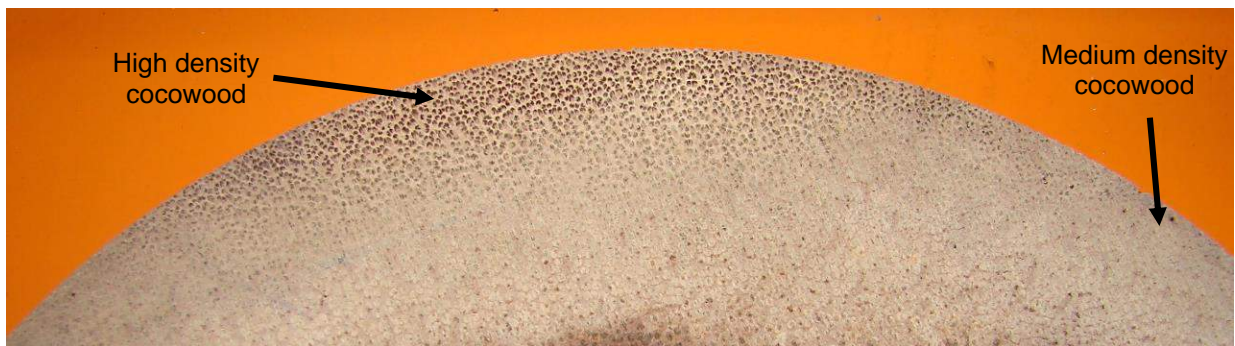
Fig. 13. Circumferential cocowood density variation

In the peripheral region of the disc containing high-density cocowood, cutting refusal and circumferential density variation can both occur. The cyclic variability in cutting forces could be simply due to the shape of the stem. Assuming circumferential homogeneity of coconut wood, ovality induces asymmetric removal of same quality coconut wood during rounding. As a consequence the cylindrical bolt that produces the continuous veneer ribbon displays a gradient of density along its circumference.
